SURVEY FINDINGS & RECOMMENDATIONS

RAINIER SCHOOL – BUCKLEY, WA

**OAKLEY HALL AND MEYER HALL ROOFING REPAIRS
AND HEMLOCK-SPRUCE HALL PARTIAL
REROOFING AND REPAIR PROJECT**

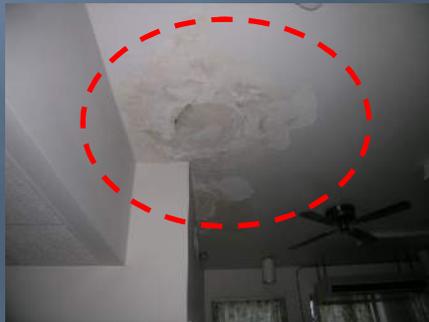
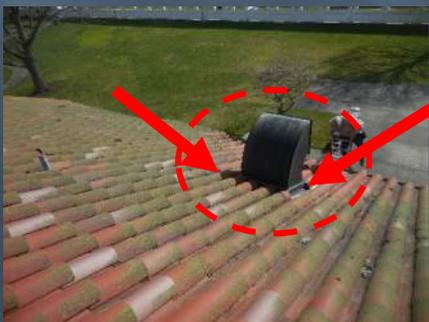
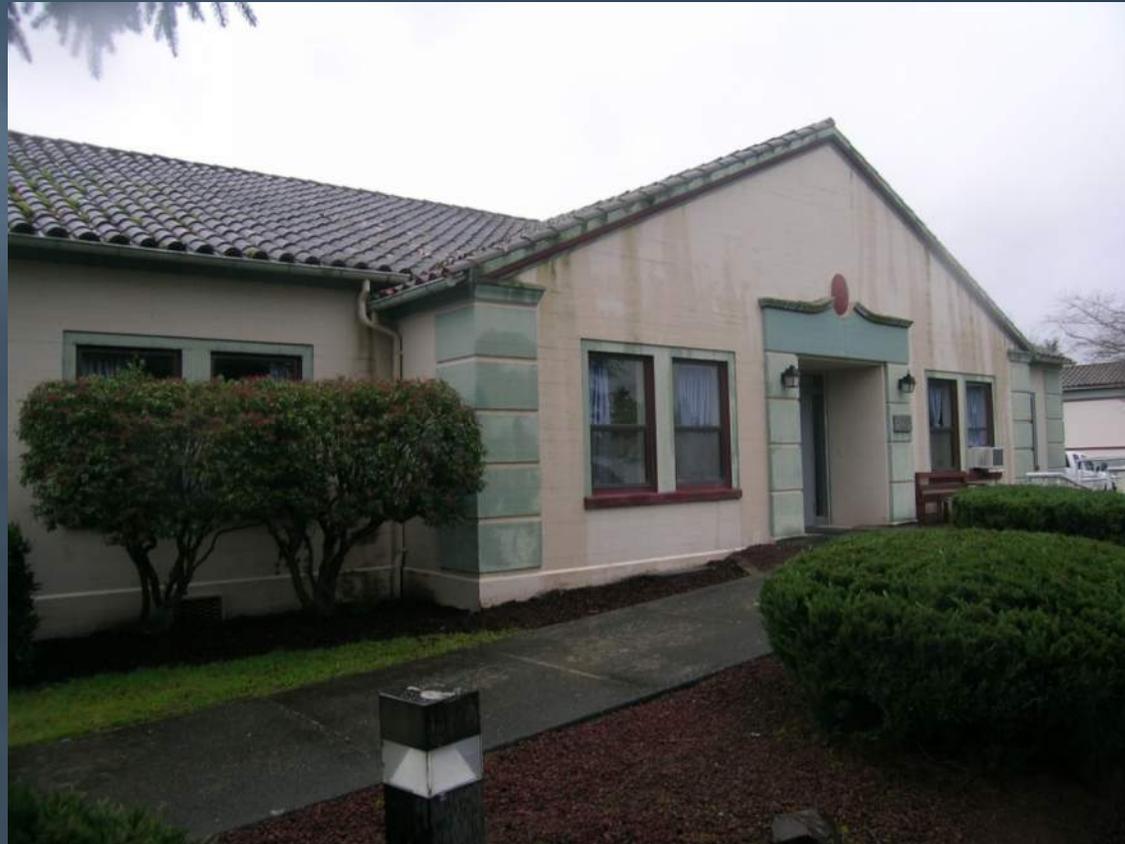
OAKLEY HALL-- OVERVIEW

Overview of Conditions at Oakley Hall

Reports of water intrusion primarily appear to be related to aged valley flashing conditions and defective flashings at select HVAC related penetrations.

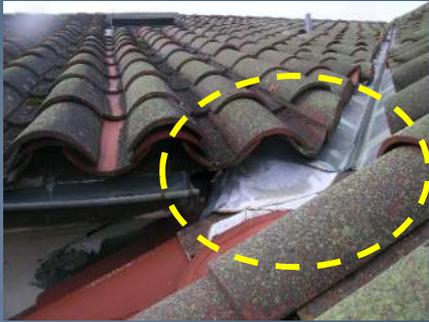
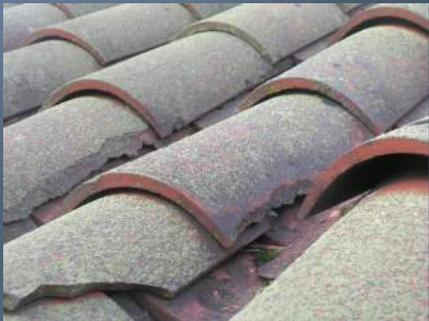
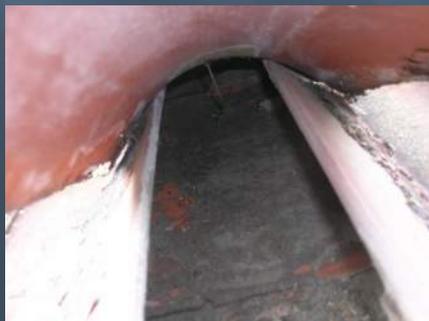
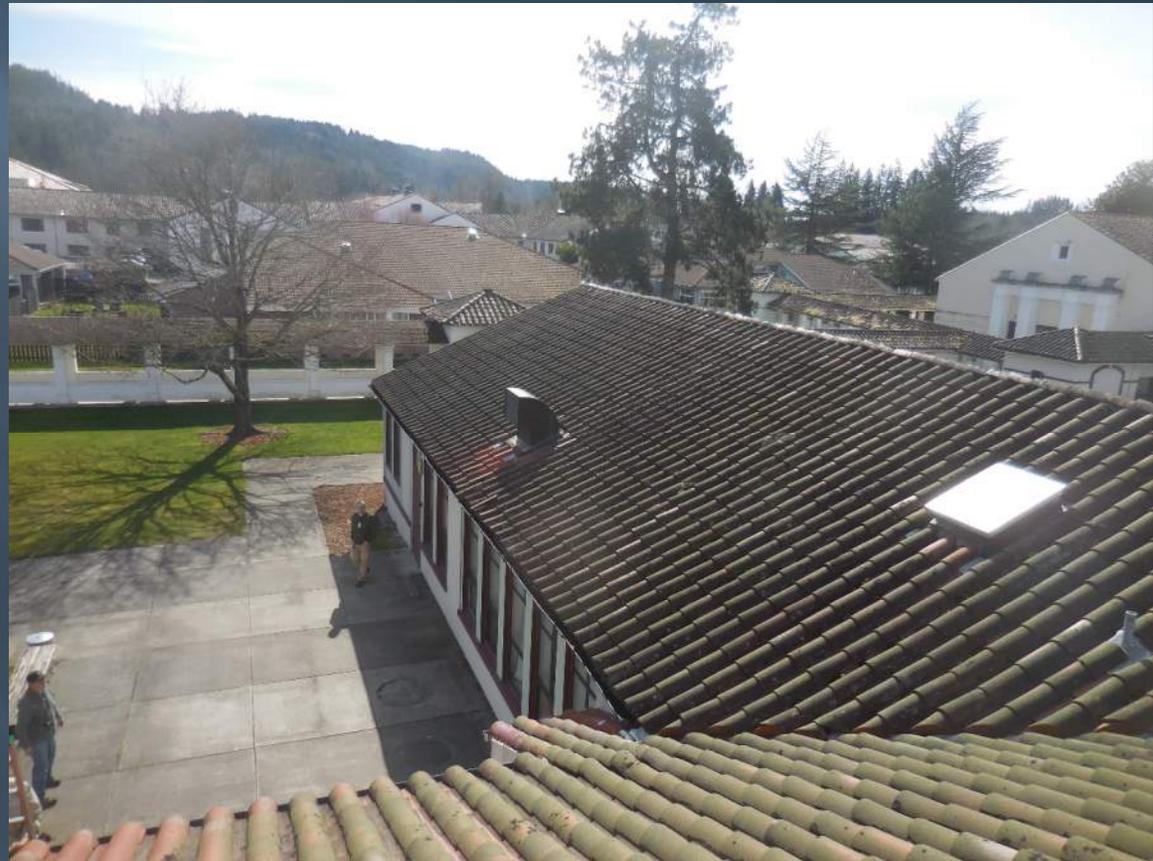
OAKLEY HALL --- GENERAL ROOF FINDINGS AND CONDITIONS

Overview of Oakley Hall pan-and-cover clay tile roofing and general survey findings.

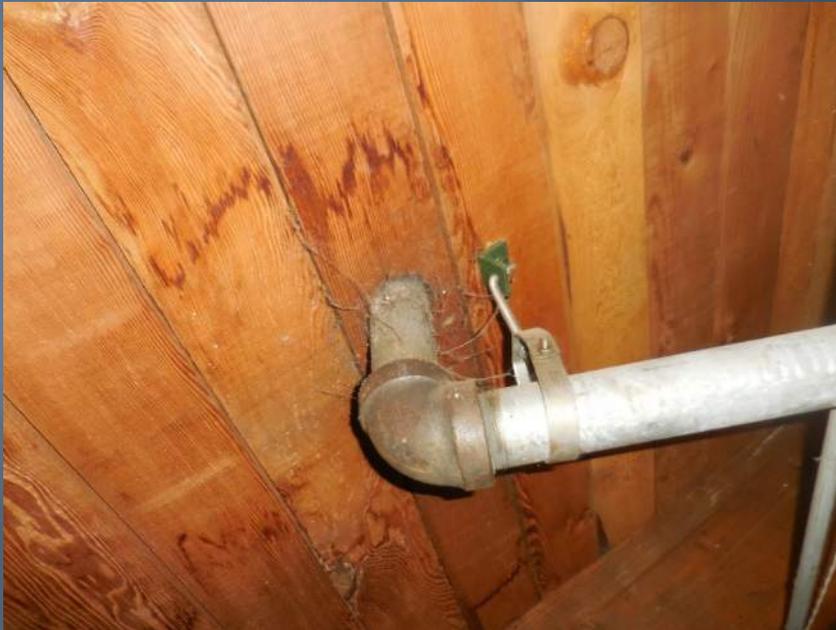
View of water staining on underside of wood car decking from attic space

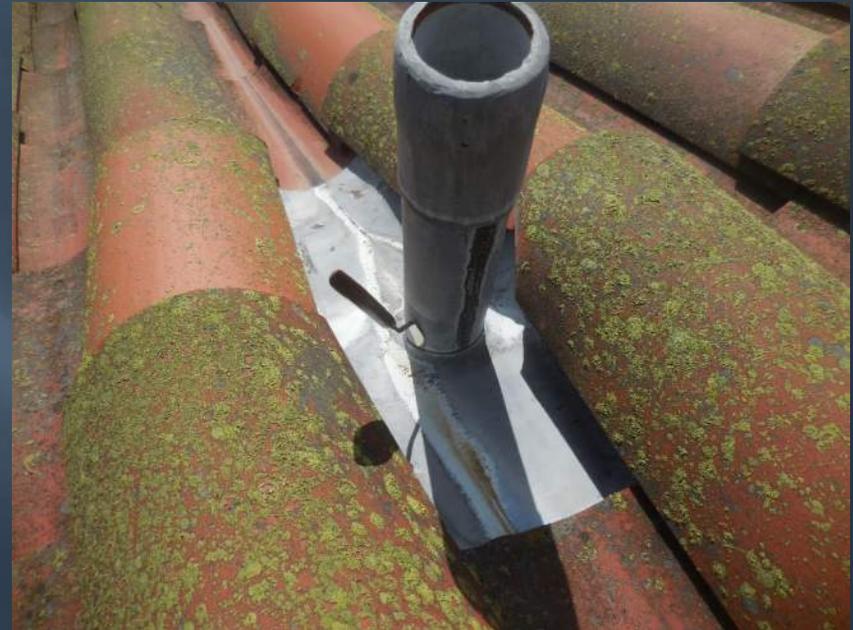
Deficient lead flashing at soil stack pipe penetration

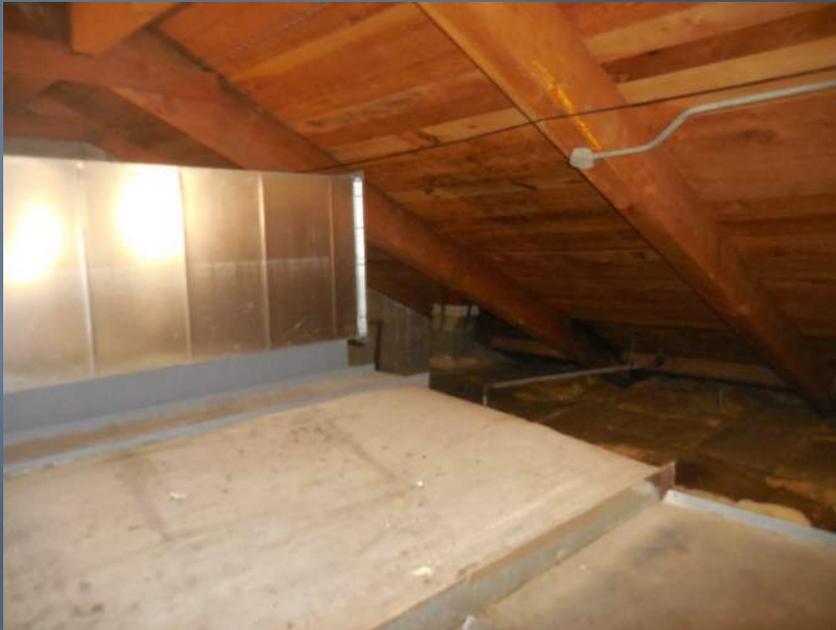
Depicts generally dry and good condition of 2x car decking and wood-framed structure

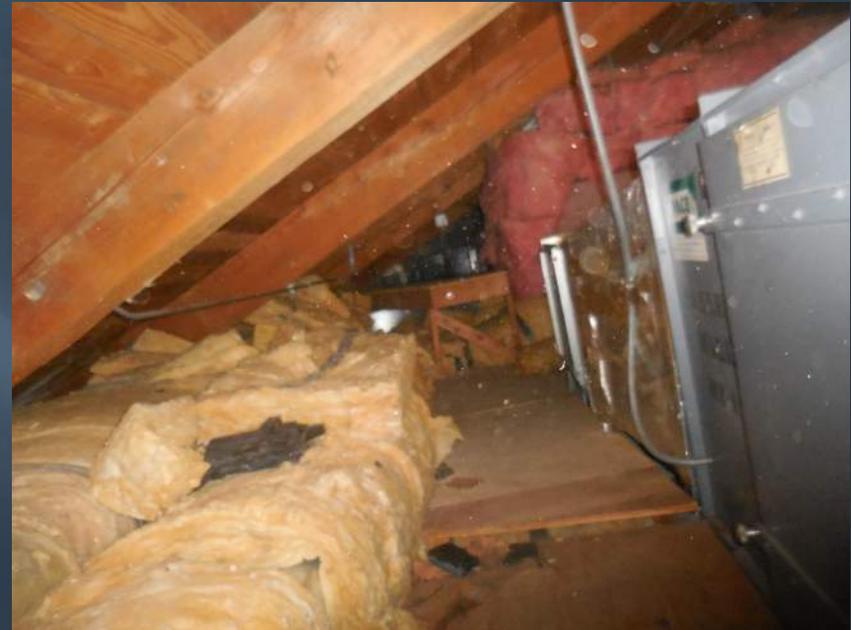
While the roofing structure appears dry, water intrusion as reported in an office below select HVAC units. The leak in office 128 appears to be related to this HVAC unit.

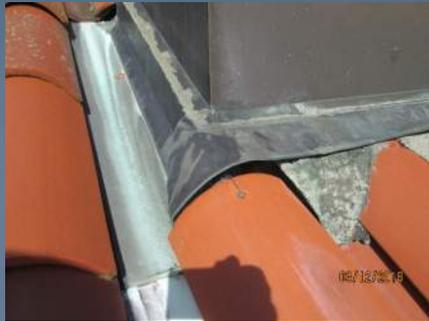
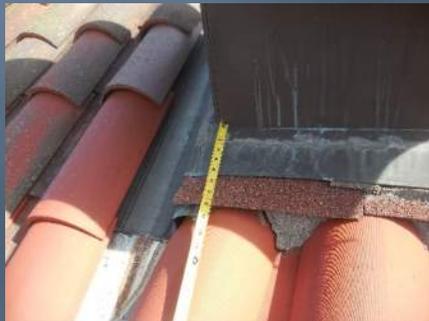
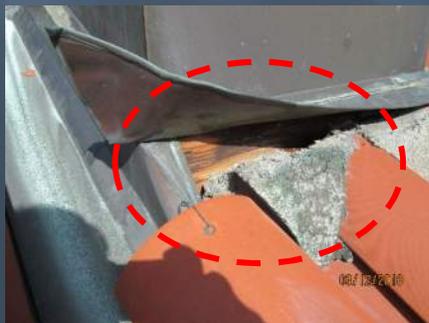
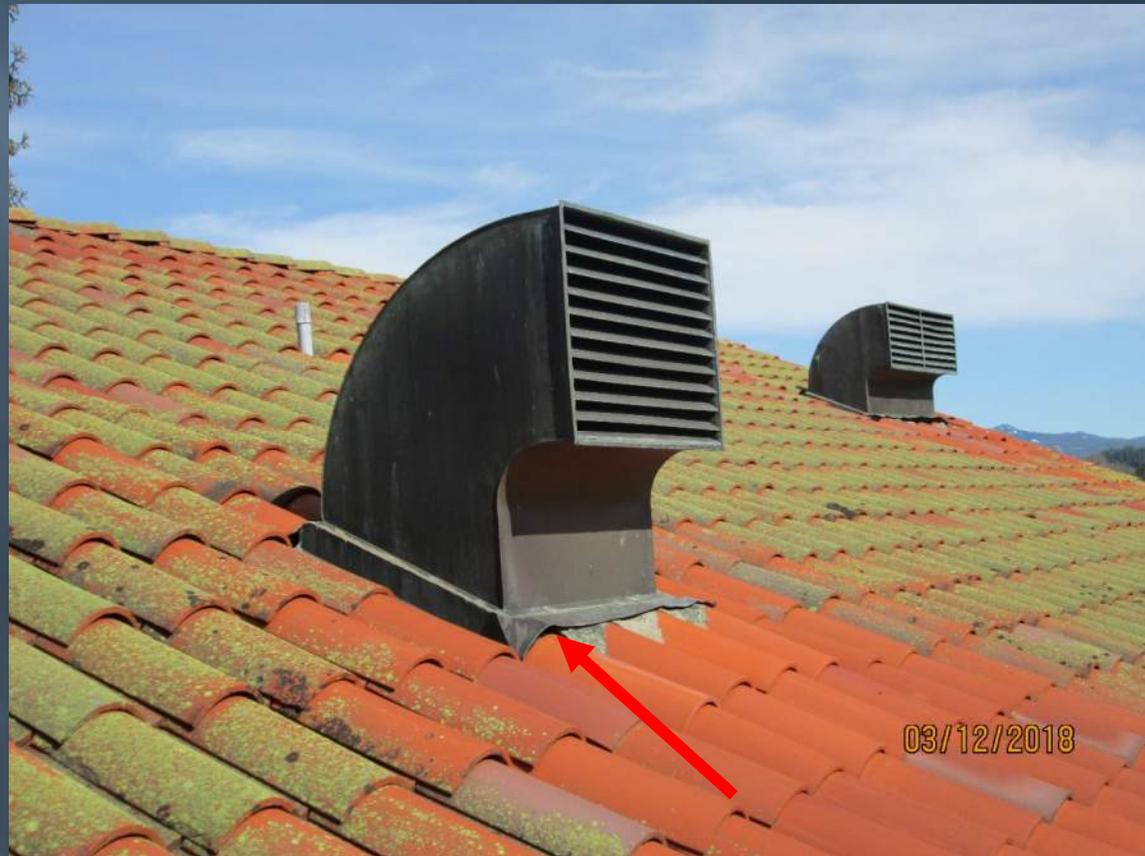
OAKLEY HALL- VENT HOOD FLASHINGS

Photos of conditions at HVAC Hood at related leak location where curb not correctly flashed.

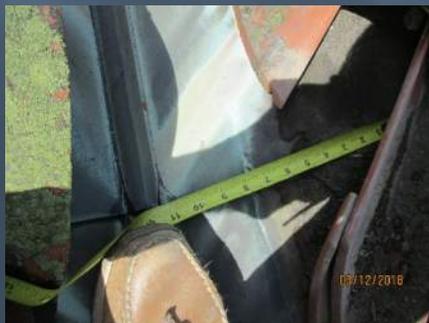
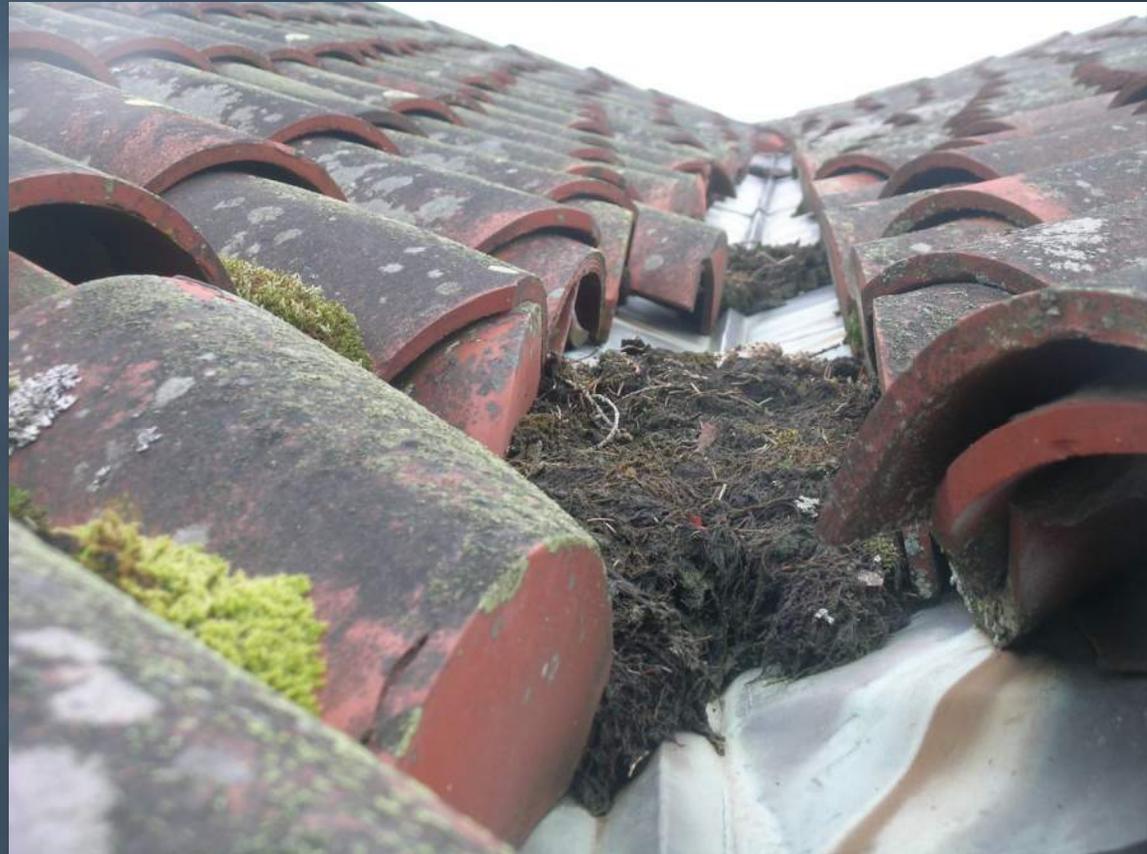
OAKLEY HALL— VALLEY FLASHINGS

Photos of conditions at typical valley

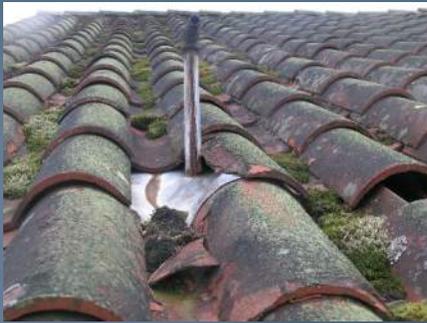
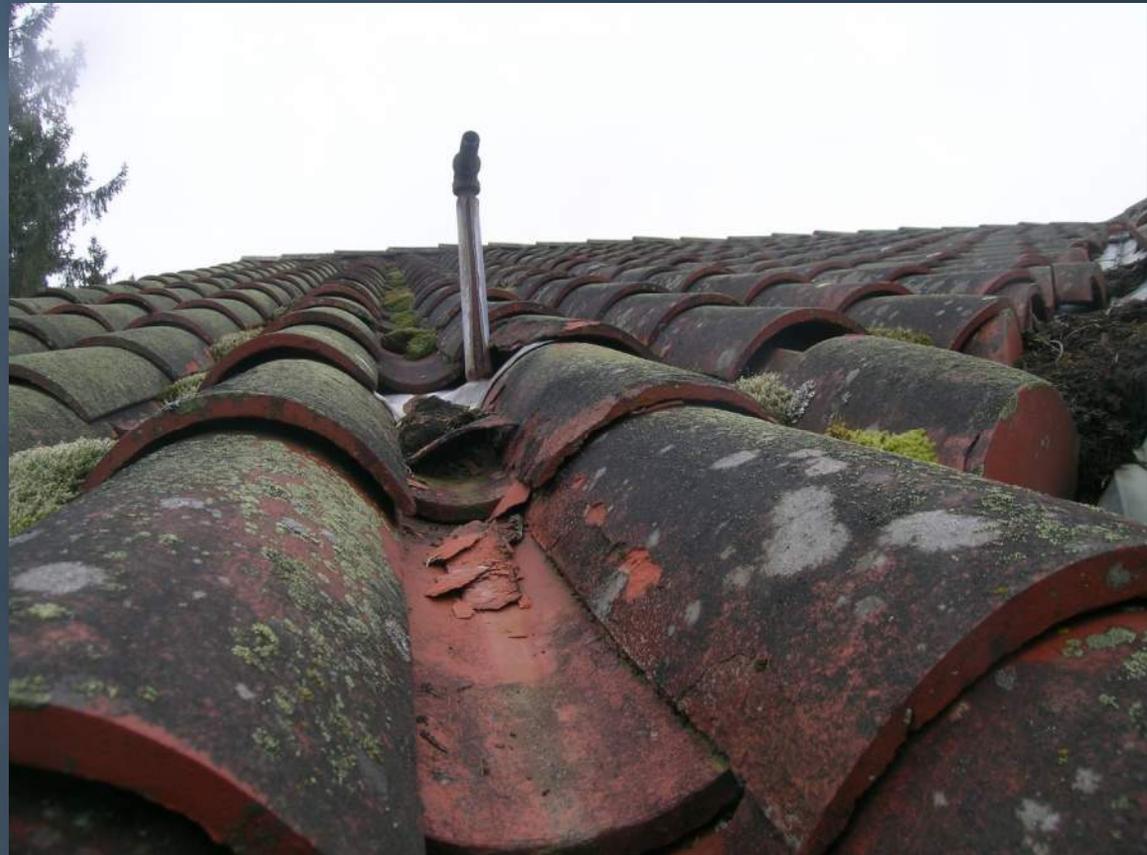
OAKLEY HALL— PIPE PENETRATION FLASHINGS

Photos of conditions at pipe penetration near northwest corner of building

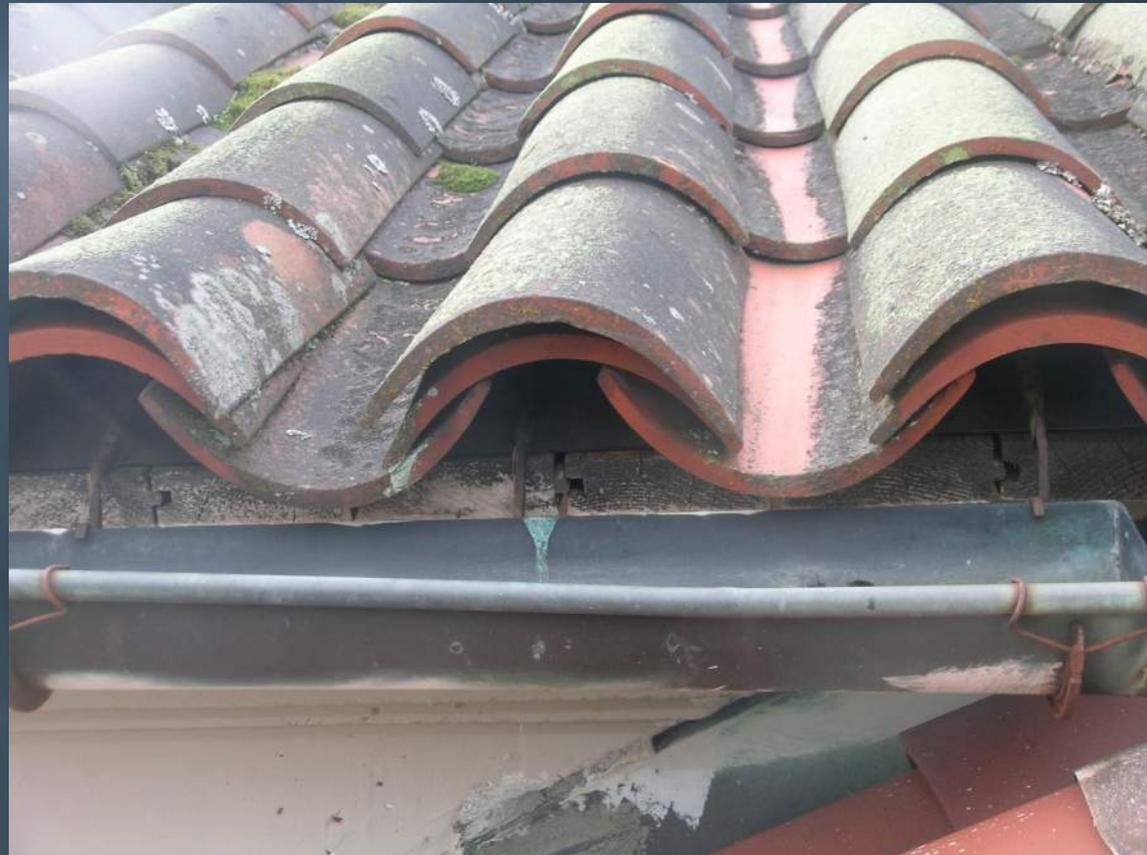
OAKLEY HALL— DOWNSLOPE EAVE EDGE CONDITIONS

Photos of conditions at downslope eave edge flashings.

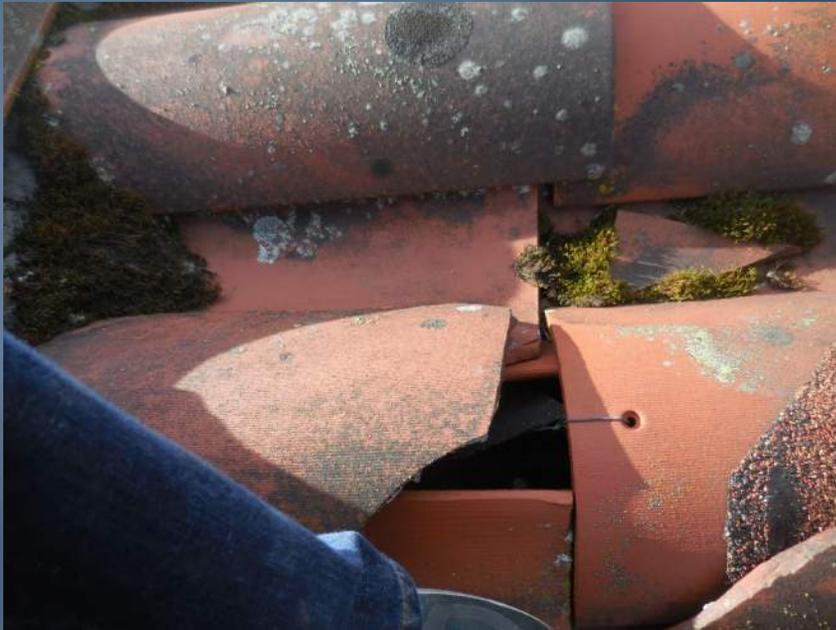
View of broken clay tile needing replacement

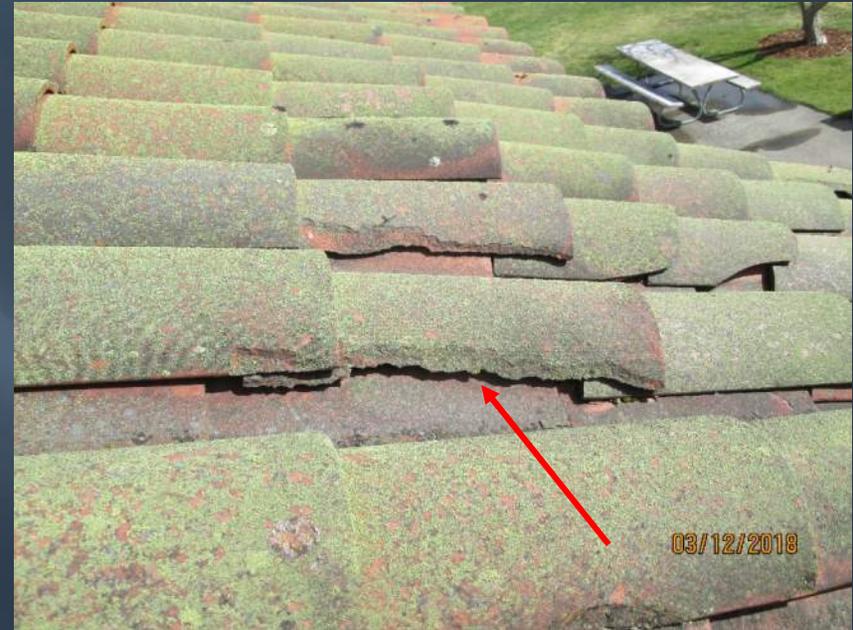
Apparent freeze-thaw damage eroding edges of select clay tiles

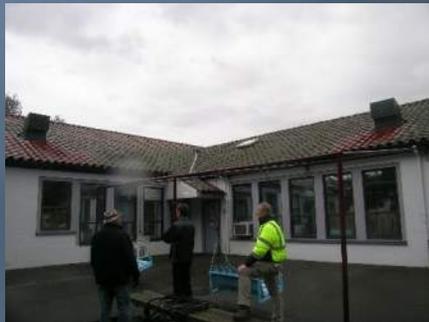
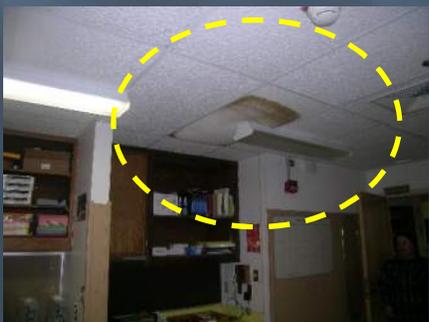
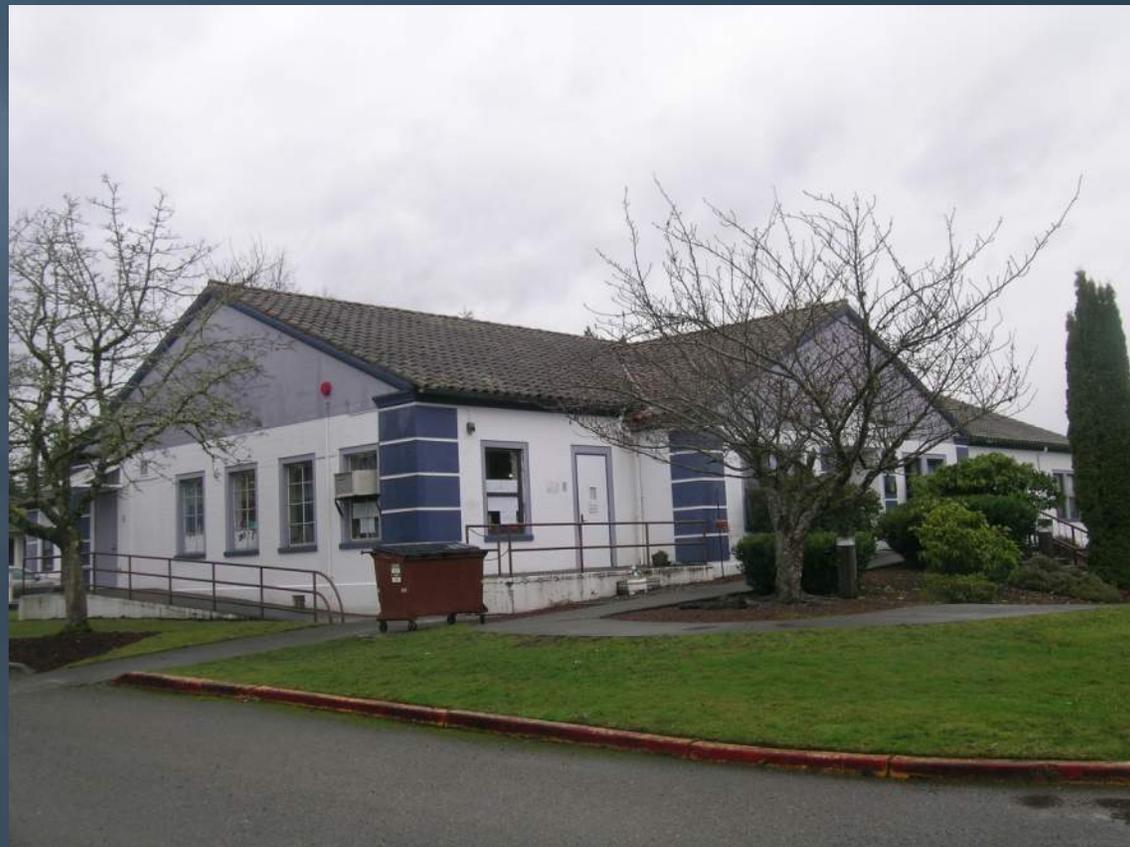
MEYER HALL-- OVERVIEW

Overview of Conditions at Meyer Hall

Reports of water intrusion also appear to be primarily related to valley flashing conditions and flashings at select HVAC units' penetrations.

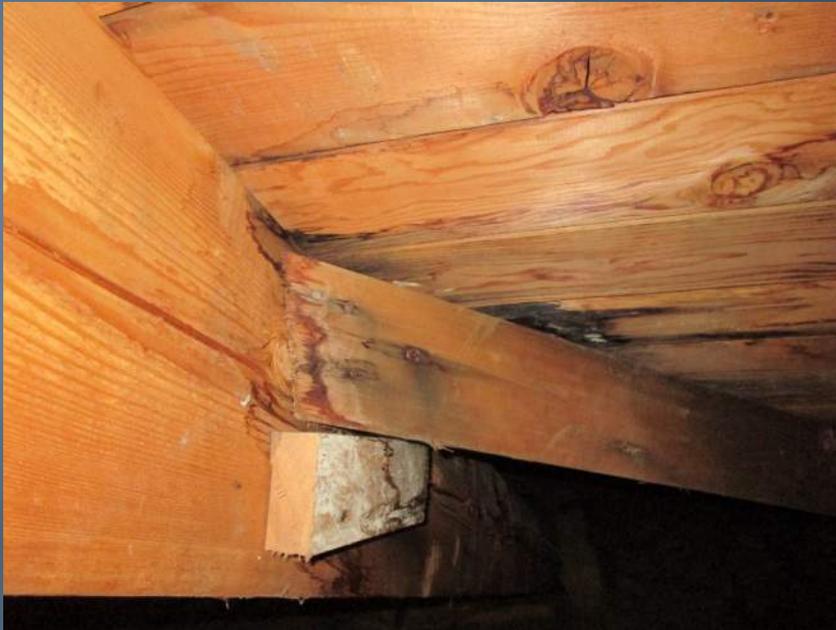
View of water stained and decayed car decking and adjacent framing members at a valley transition.

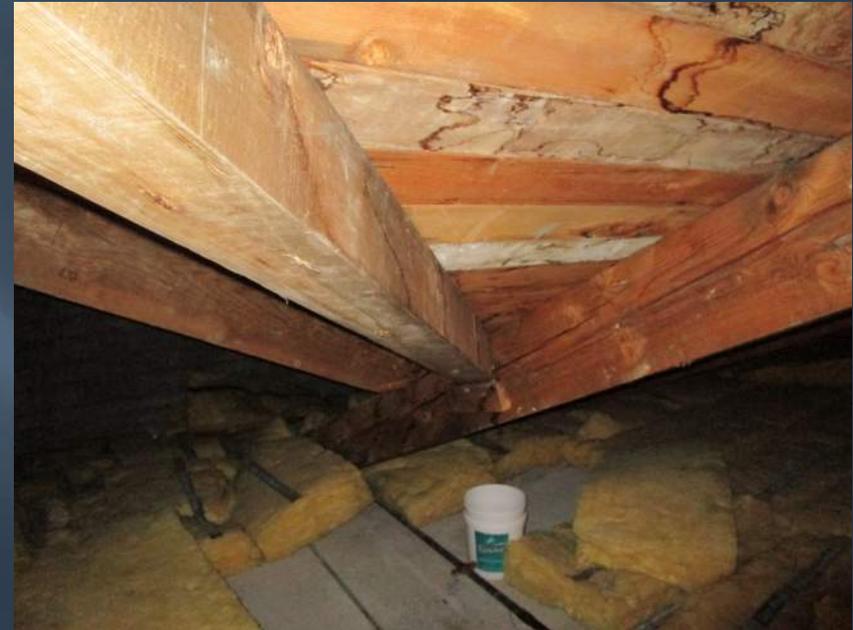
Placement of buckets to collect rain water run-off leaks. Note: insulation has been displaced on concrete ceiling due to previous water intrusion.

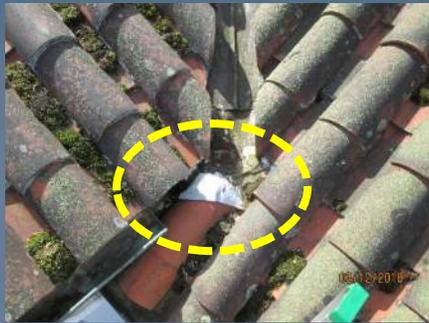
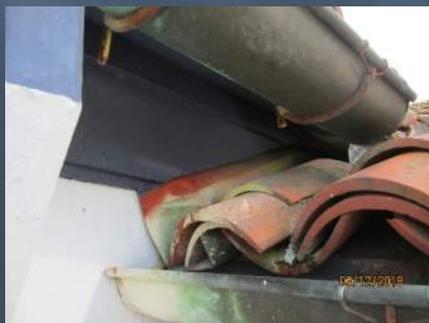
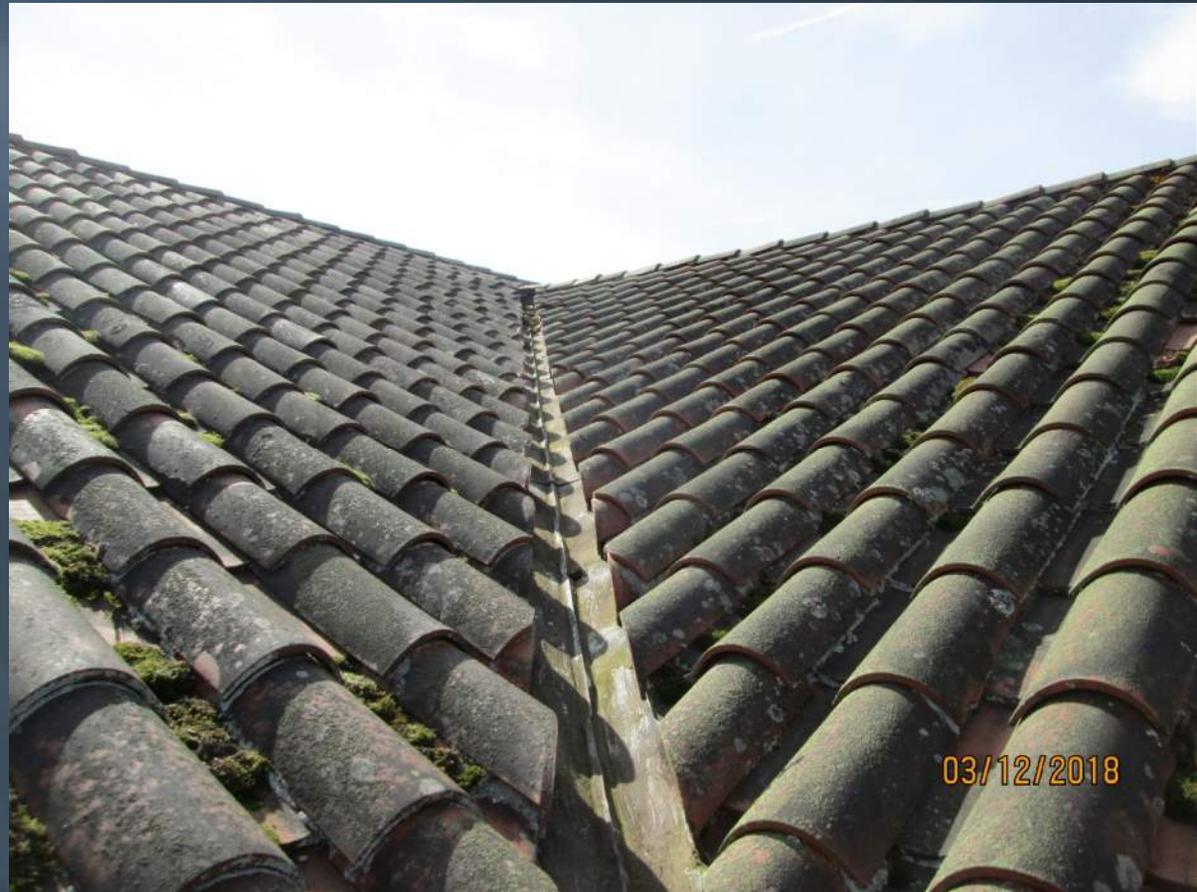
MEYER HALL— VALLEY CONDITIONS

Overview of Roof Level Valley Conditions

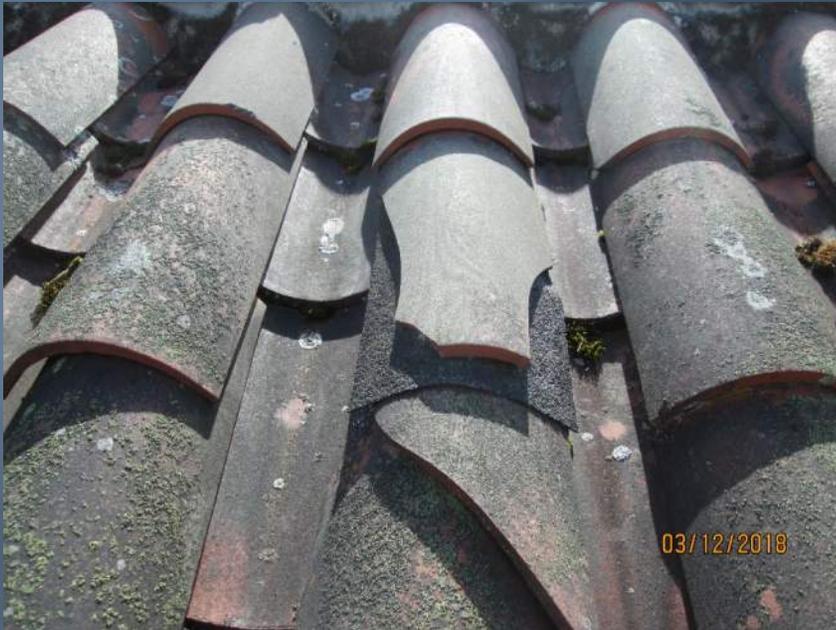
View of broken clay tile needing replacement

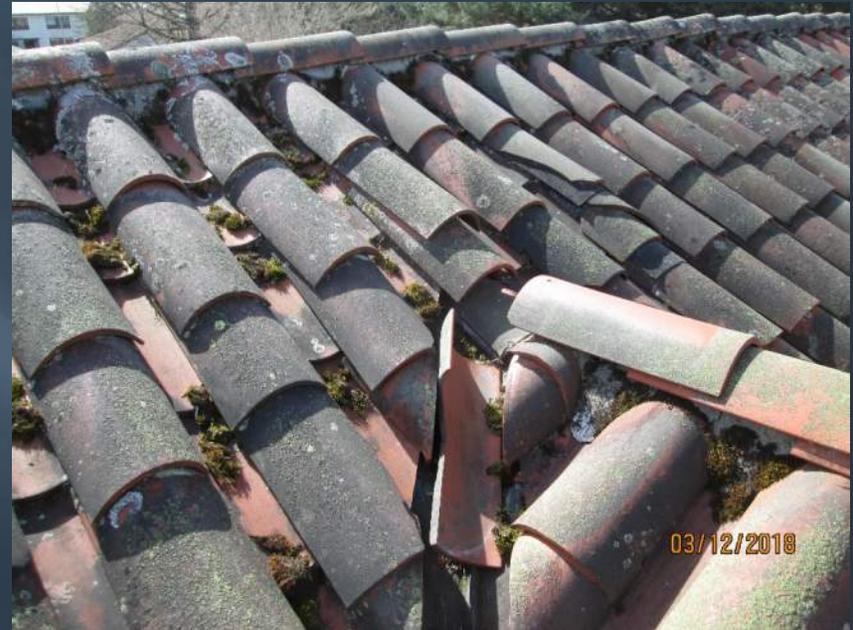
Misplaced tiles at valley-to-ridge transitions.

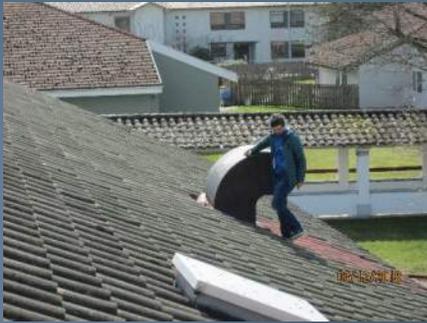
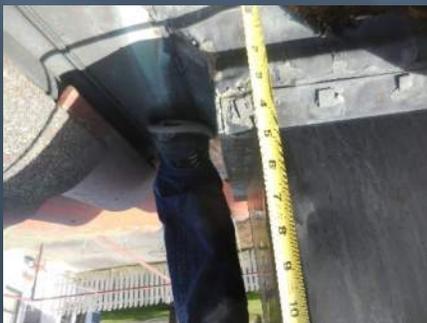
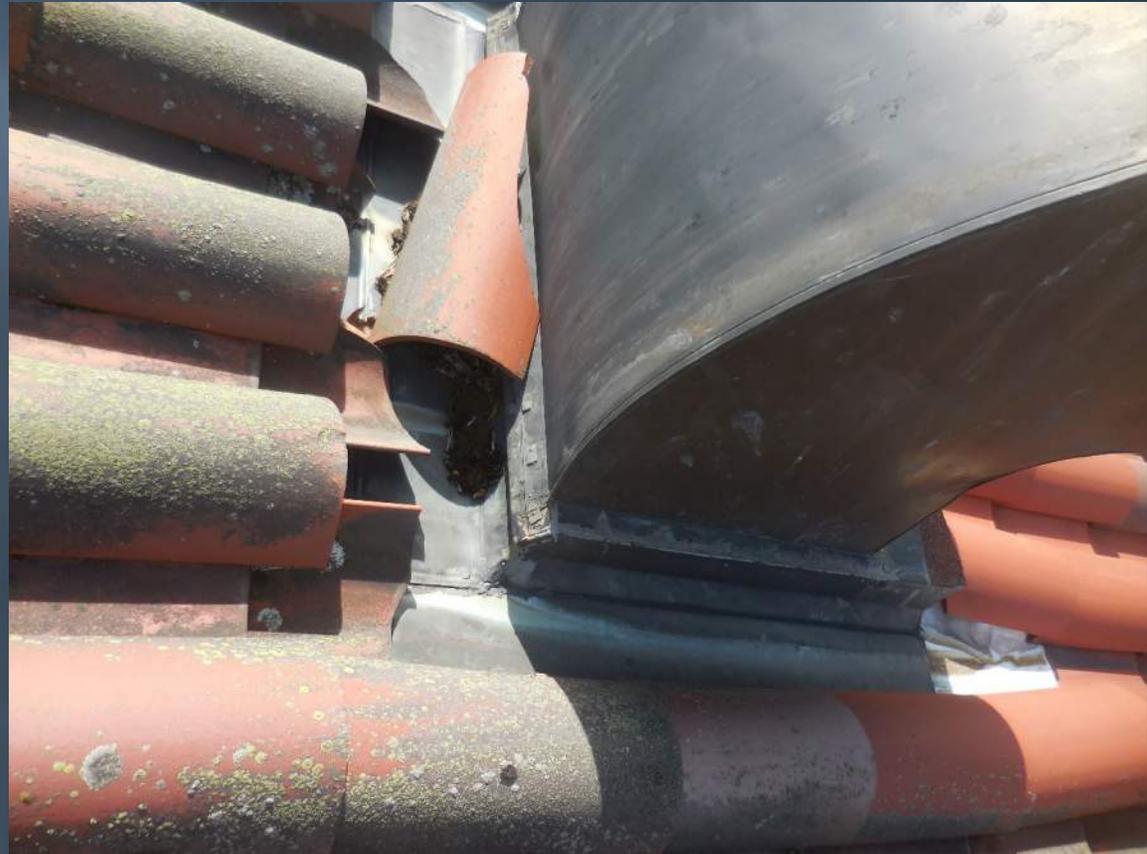
MEYER HALL— VENT HOOD FLASHINGS

Photos of flashing conditions at typical HVAC Hood.

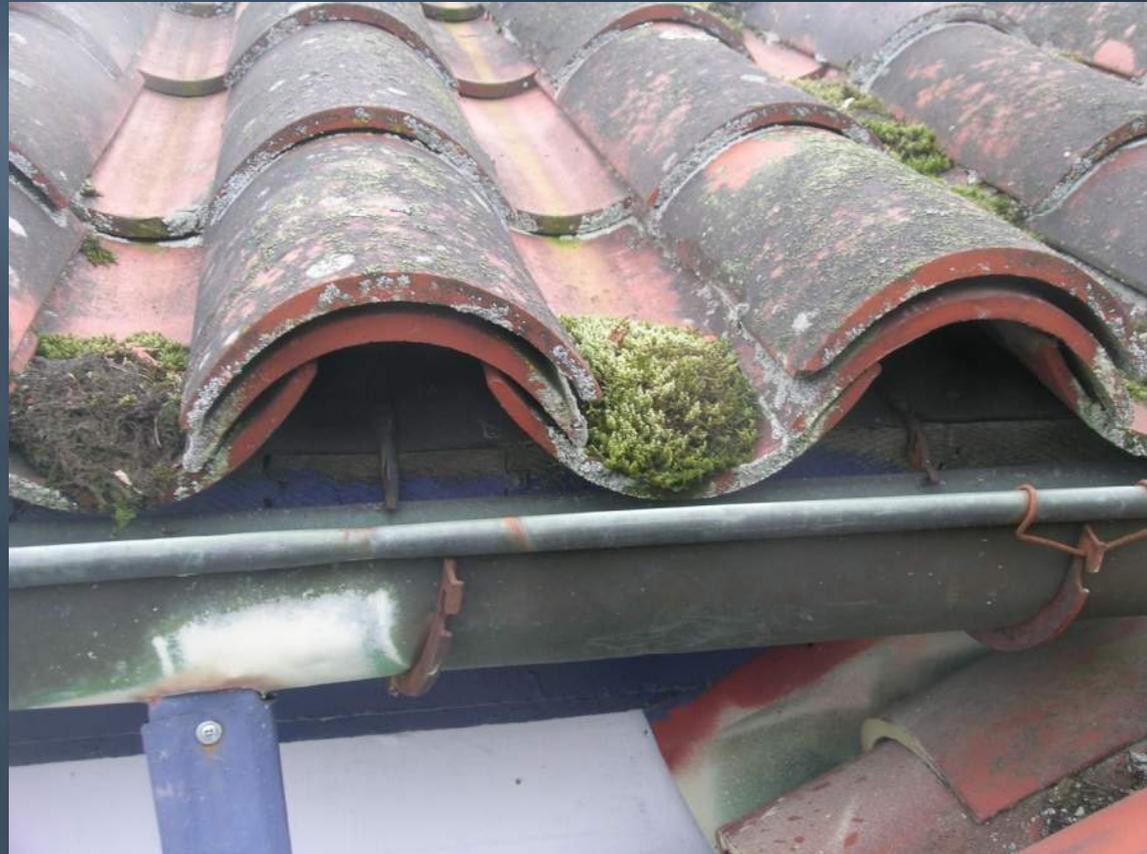
MEYER HALL— DOWNSLOPE EAVE EDGE CONDITIONS

Photos of conditions at downslope eave edge flashings.

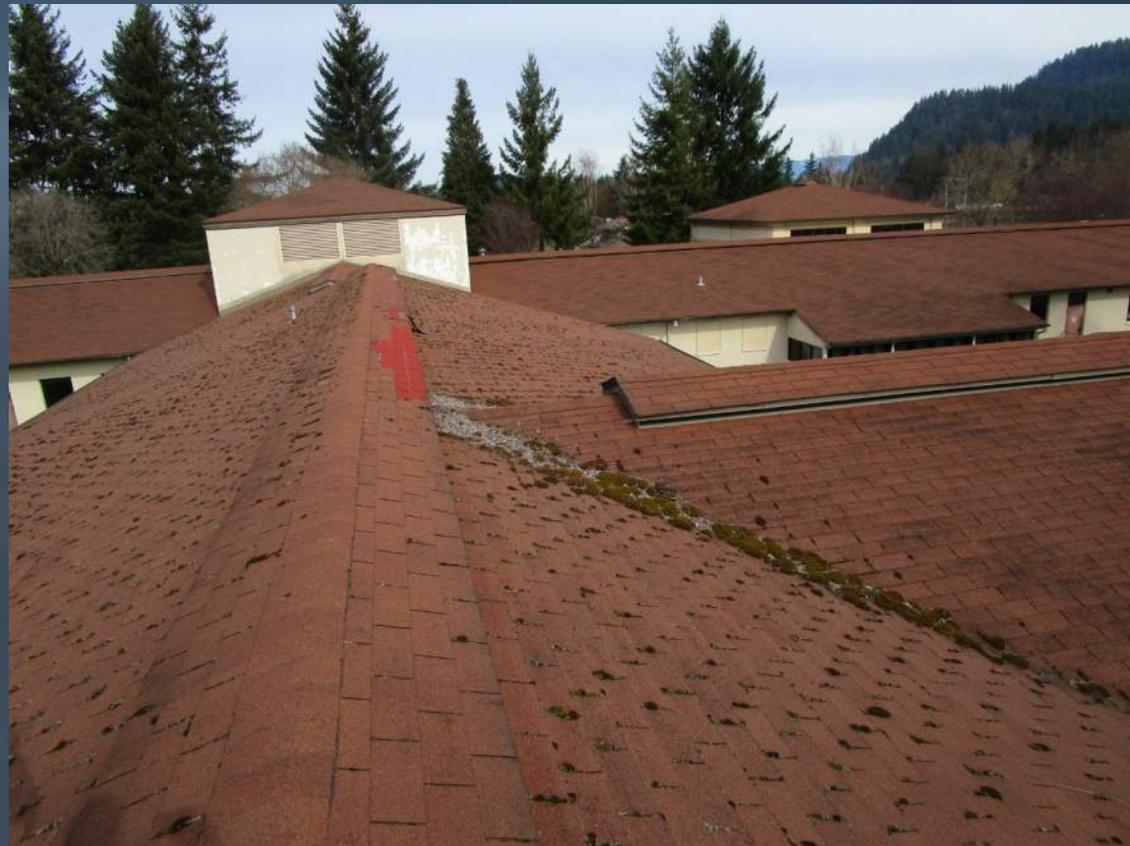
HEMLOCK-SPRUCE- OVERVIEW OF ROOF CONDITIONS

Overview of Conditions at hemlock-Spruce Hall
The existing 3-tab asphalt shingles appear to be approaching 26+ years of service life, are cracking and are generally in need of replacement.

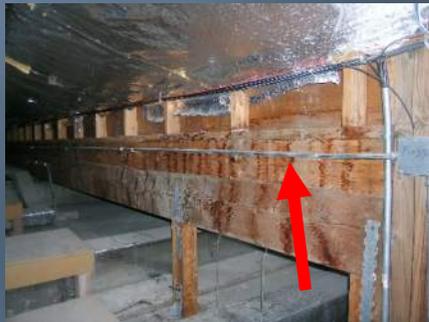
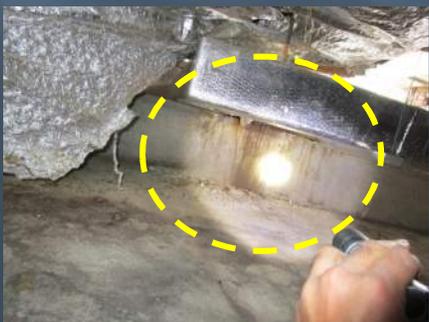
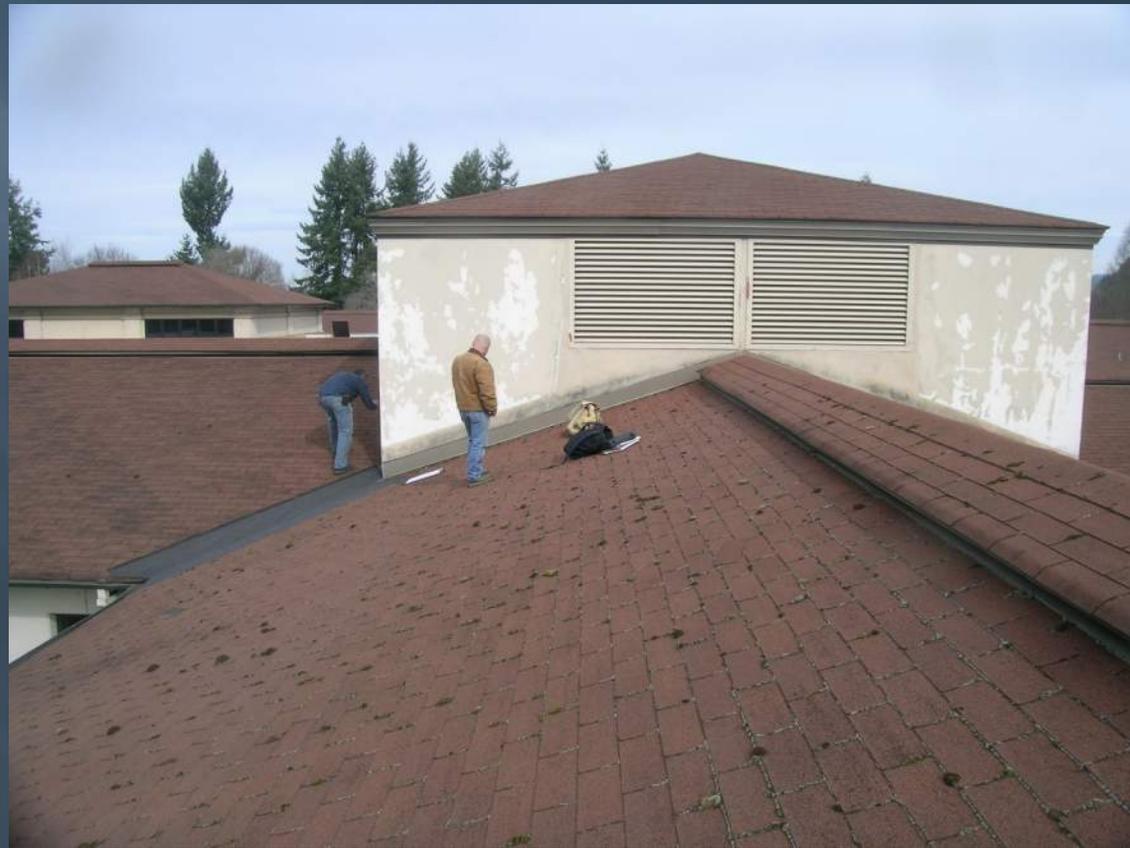
HEMLOCK-SPRUCE- CONDITIONS AT CUPOLAS

General Conditions at Cupolas

Water intrusion appears to be occurring at roof-to-wall transition at areas related to valley flashings.

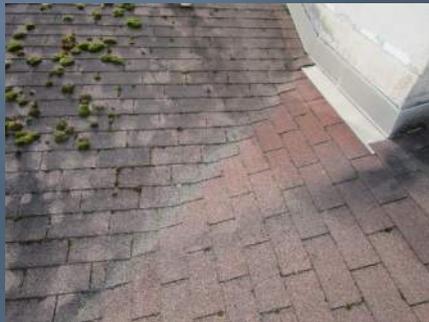
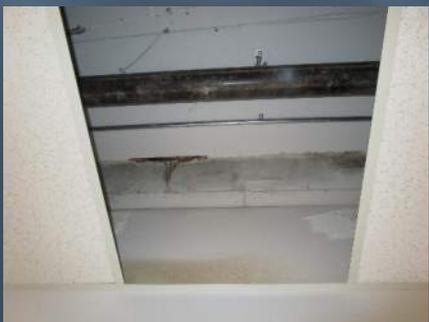
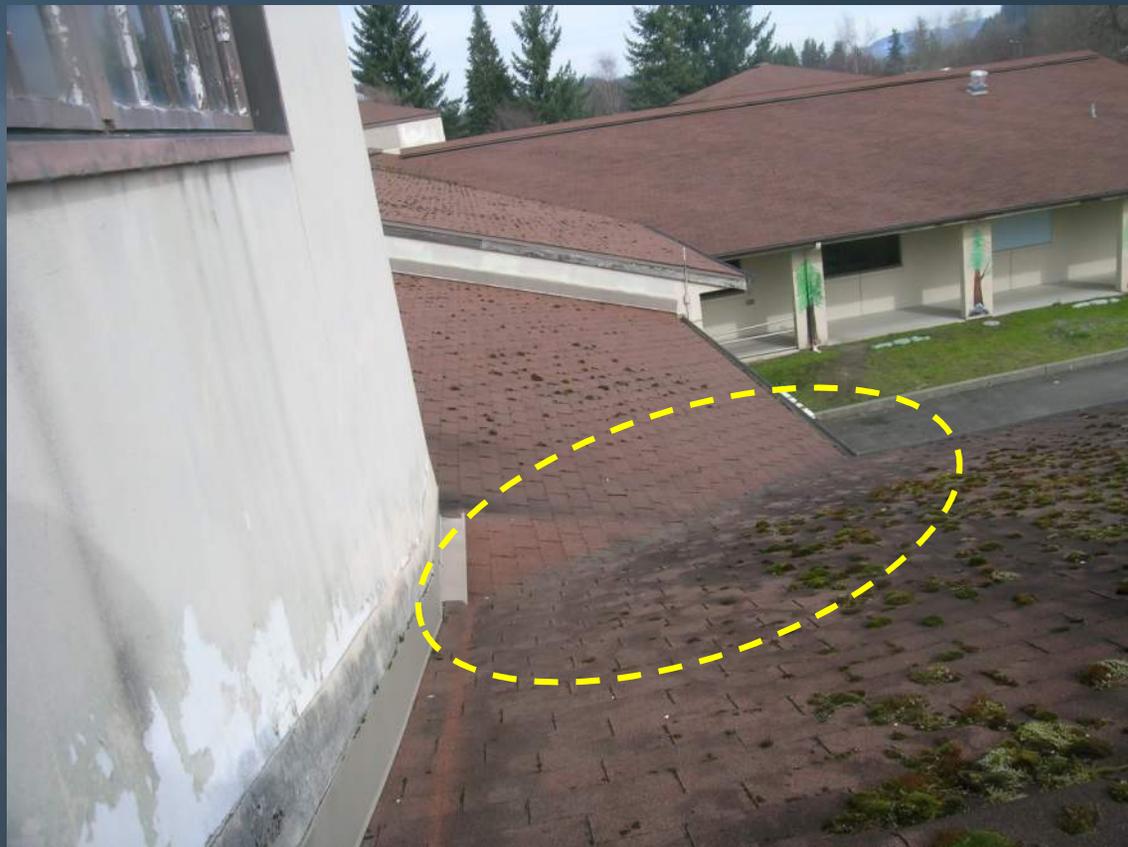
HEMLOCK-SPRUCE- REPORTED LEAK LOCATIONS

Water Intrusion Beneath Woven Valleys

Water intrusion reported in hallway near wood shop appears to be emanating from asphalt shingle woven valley.

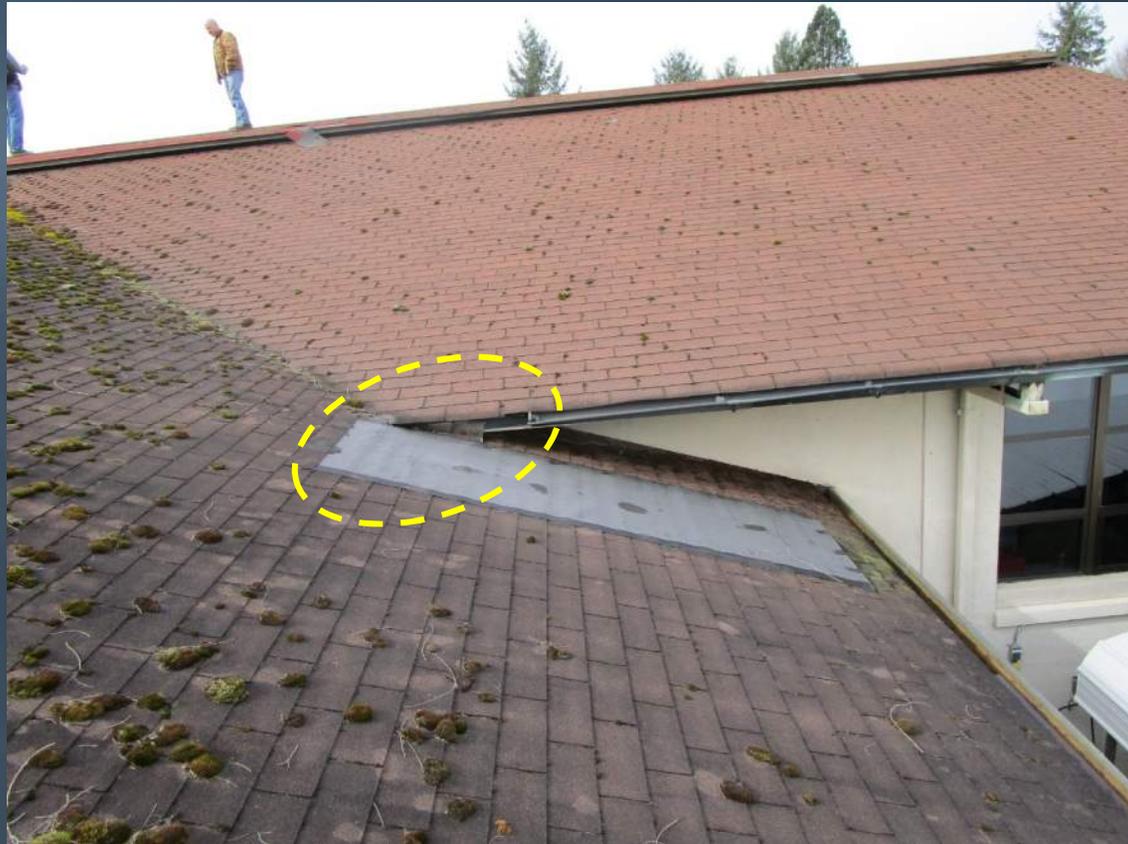
HEMLOCK-SPRUCE- REPORTED LEAK LOCATIONS

Water Intrusion at Valley-to-Roof Transition at Art Room
Water intrusion reported in the Arts Classroom appears to be related to valley-to-intersecting roof transition.
