SURVEY FINDINGS & RECOMMENDATIONS

RAINIER SCHOOL – BUCKLEY, WA

**OAKLEY HALL AND MEYER HALL ROOFING REPAIRS
AND HEMLOCK-SPRUCE HALL PARTIAL
REROOFING AND REPAIR PROJECT**

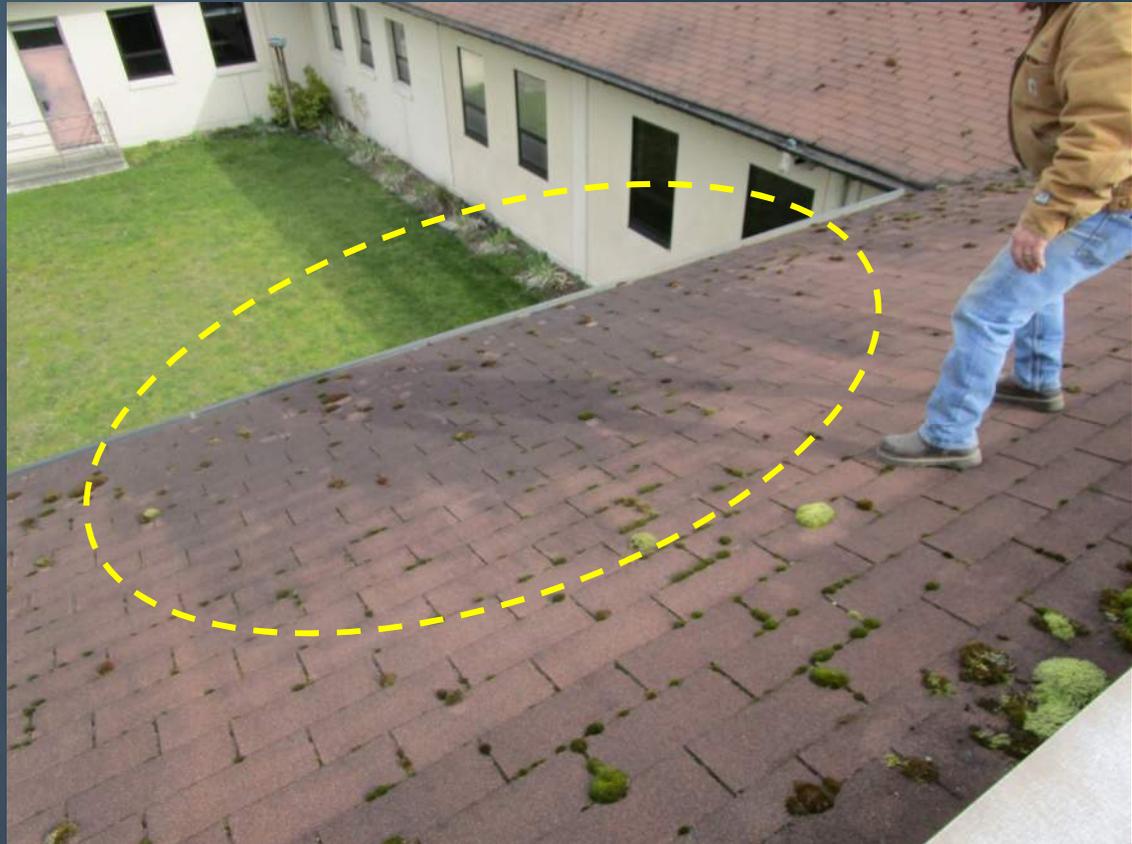
HEMLOCK-SPRUCE- REPORTED DECAYED SHEATHING

Soft, Decayed Sheathing Beneath Shingles

Although no interior leaks have been reported at this area, the sheathing is decayed / degraded and quite soft. Replacement of sheathing is needed.

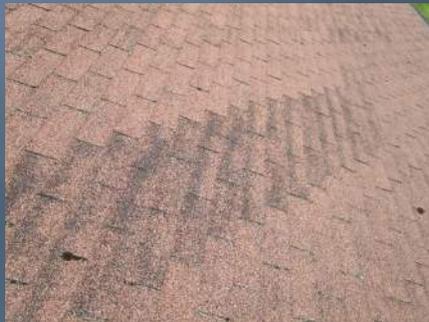
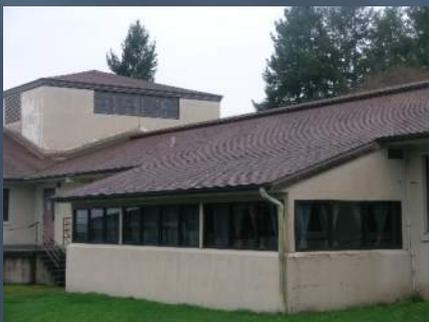
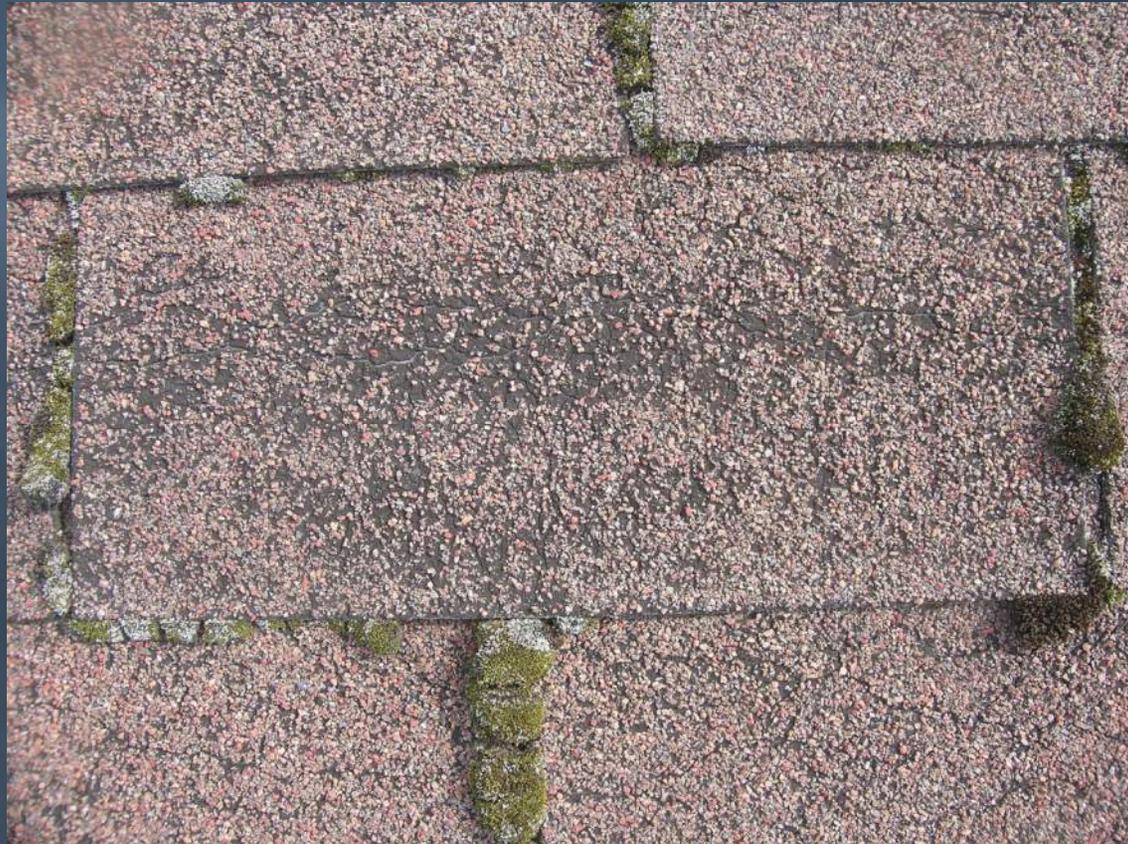
HEMLOCK-SPRUCE- SHINGLE CONDITION

Overall Condition of Existing 3-tab Asphalt Shingles
The existing 3-tab asphalt shingles are generally in poor condition. Extensive granule loss is widespread with reinforcing degrading from long-term exposure.

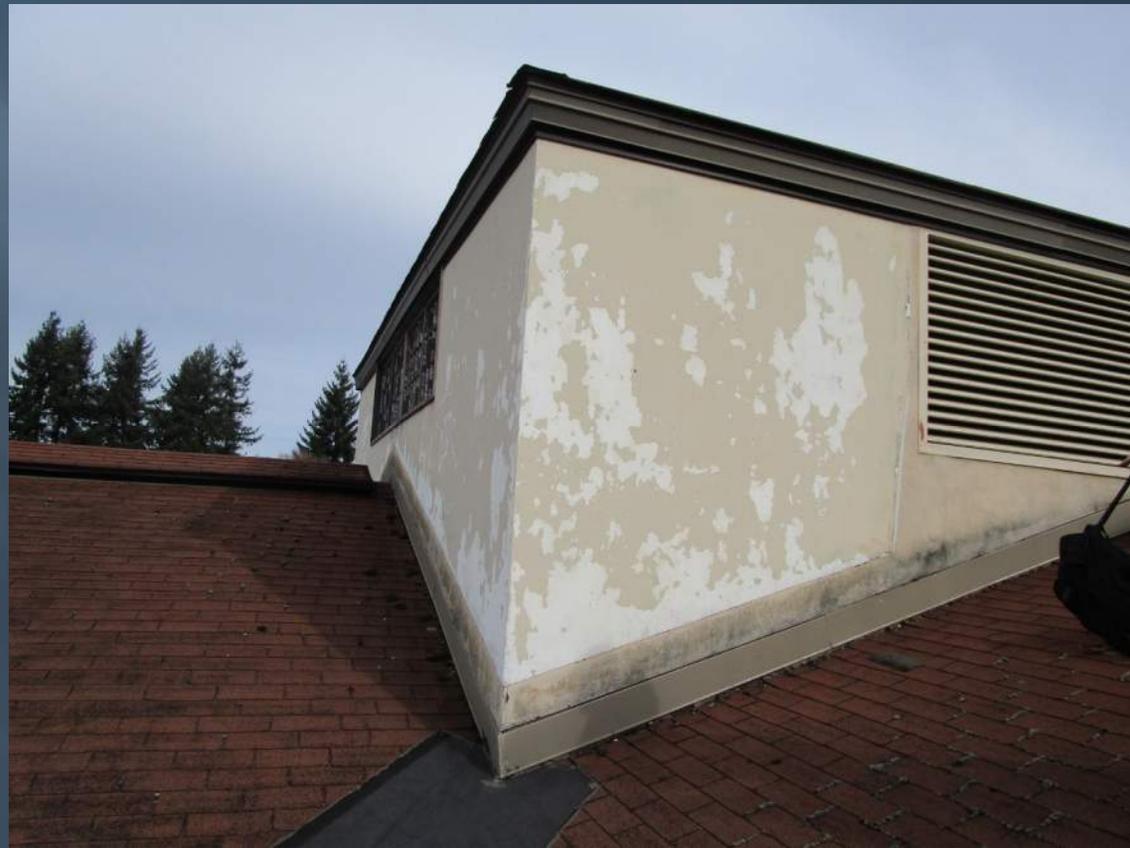
HEMLOCK-SPRUCE- CONDITIONS AT CUPOLA

General Conditions at Cupolas

Water intrusion appears to be occurring at roof-to-wall transition at areas related to valley flashings.

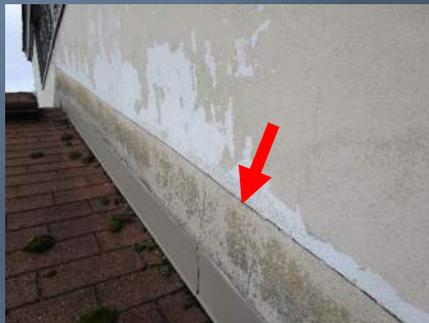
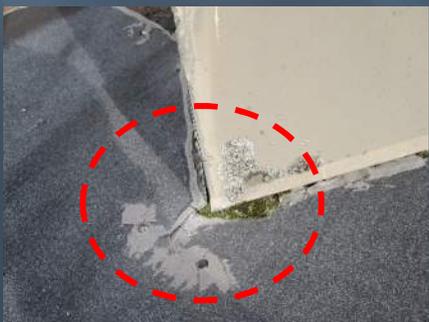
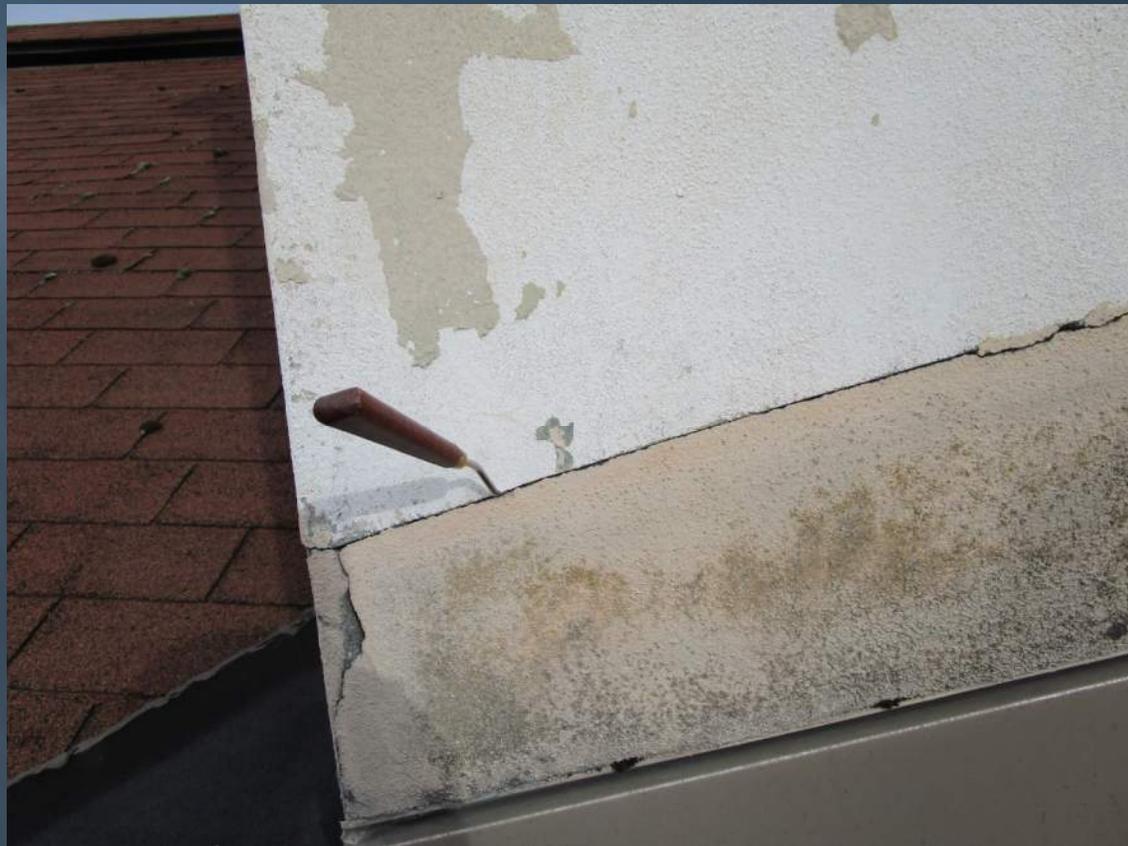
HEMLOCK-SPRUCE- CONDITIONS AT CUPOLA

General Conditions at Cupolas

Stucco repairs and proper integration with weather-resistive barrier are needed as part of the retrofit of roof-to-wall flashing details.

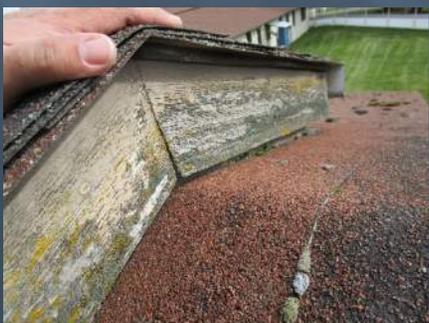
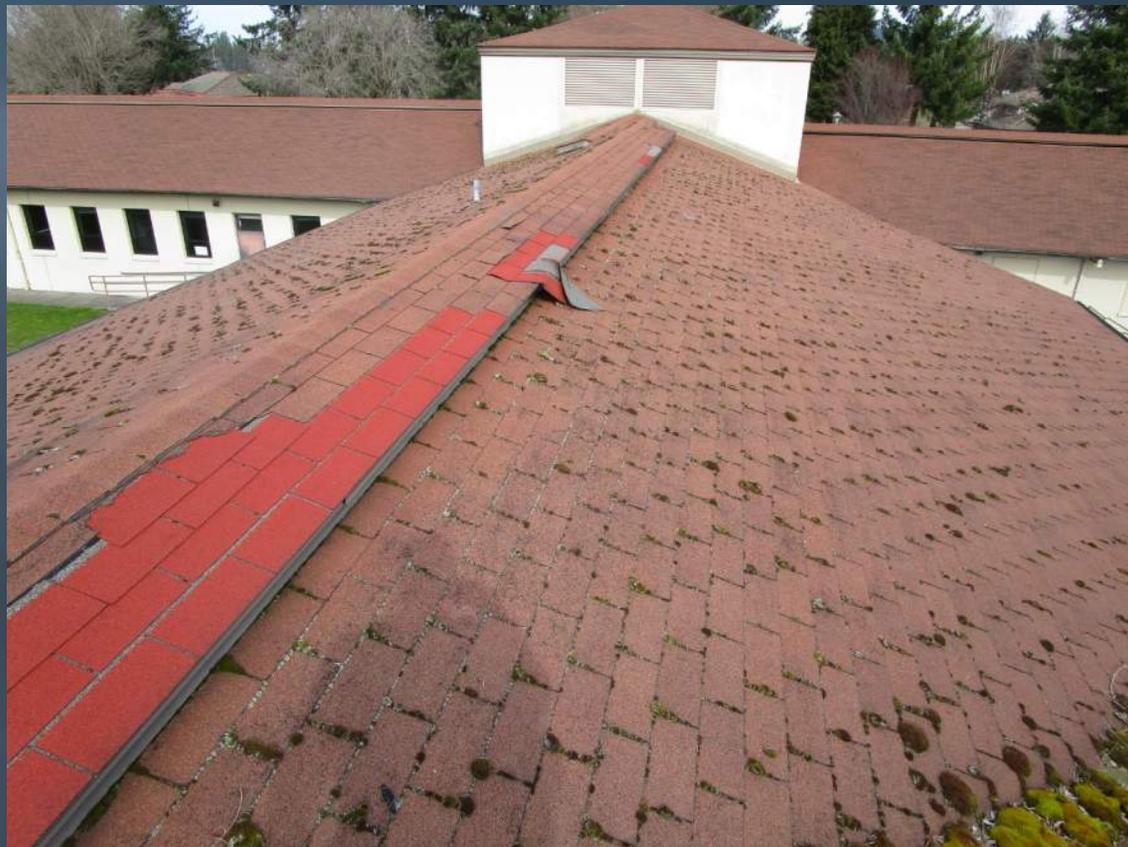
HEMLOCK-SPRUCE- RIDGE VENT OBSERVATIONS

General Conditions at Ridge Vents

Wood-framed ridge vents have experienced shingles being blown off and are susceptible to water intrusion and wind-driven rain.

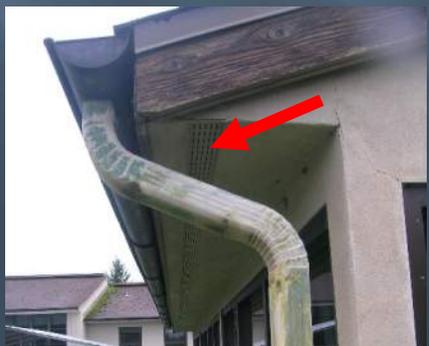
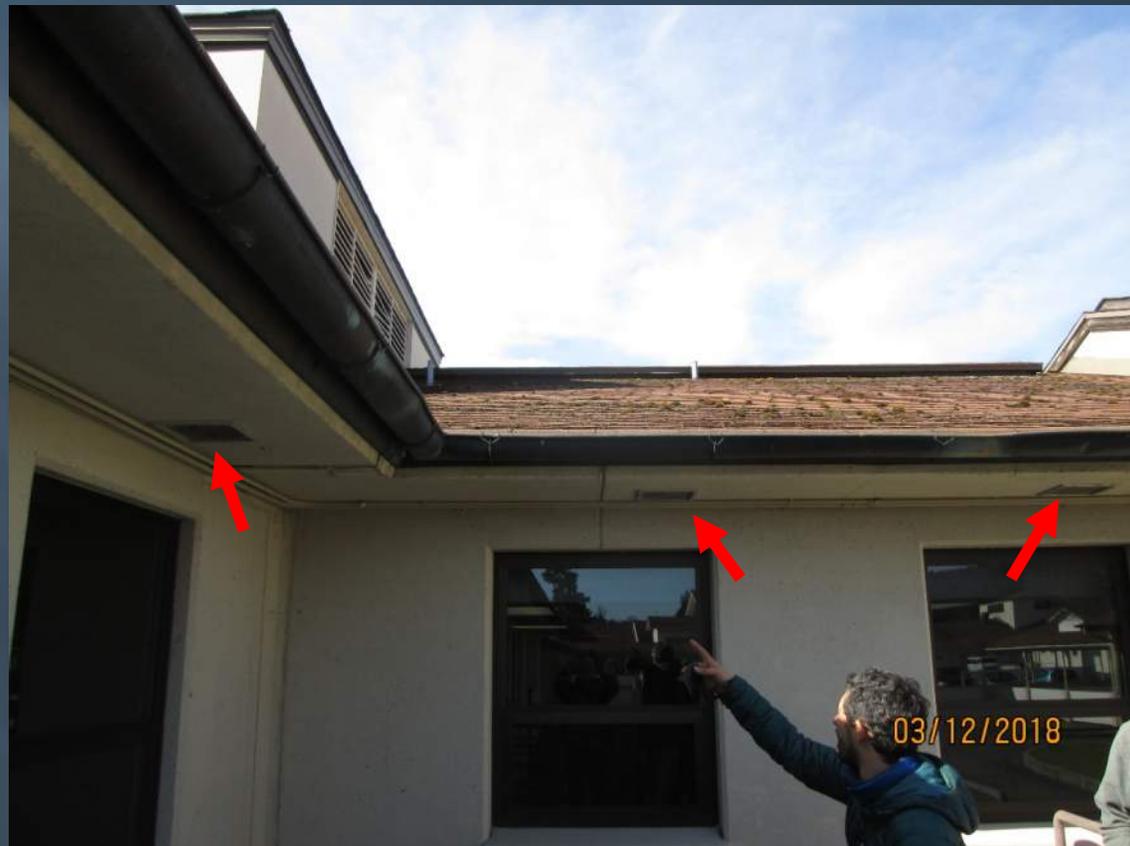
HEMLOCK-SPRUCE- SOFFIT VENT OBSERVATIONS

General Conditions at Soffit Vents

Downslope eave in-take air ventilation provided by intermittent 6" diameter soffit vents at some locations, and strip vents at others.

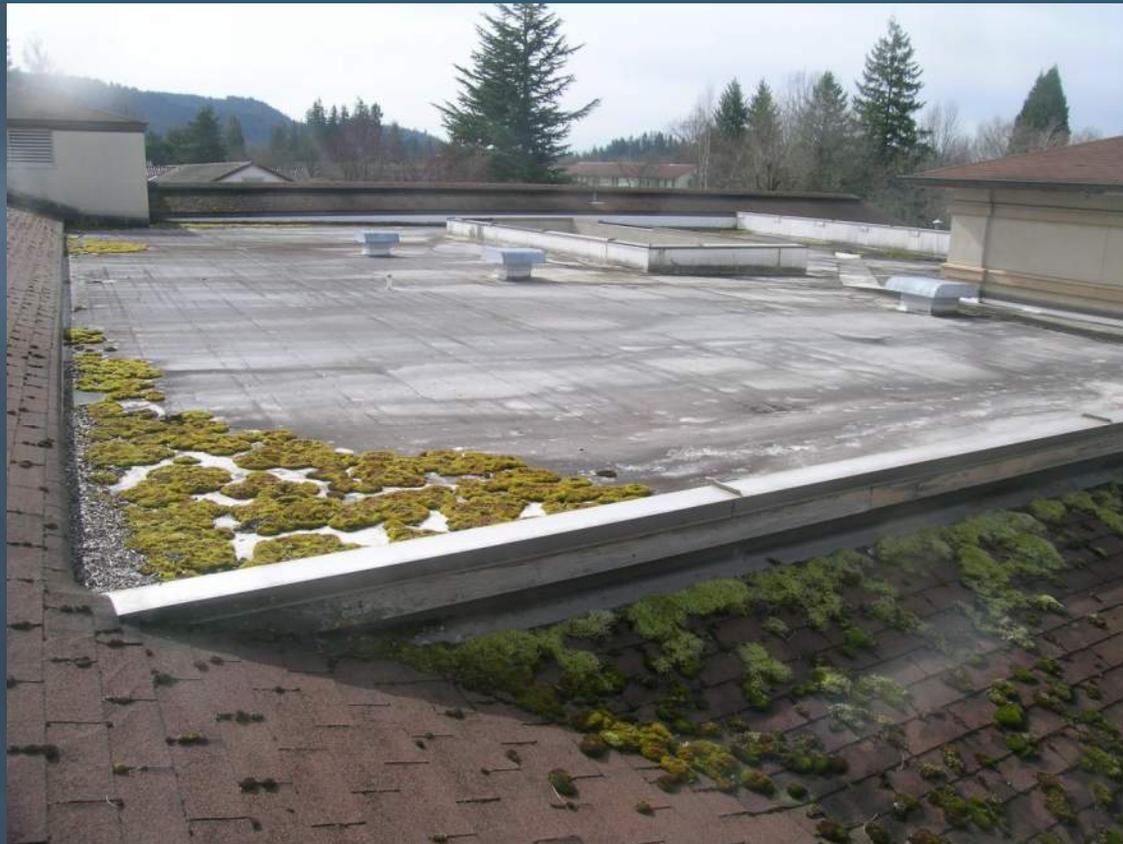
HEMLOCK-SPRUCE- LOW-SLOPE ROOF OBSERVATIONS

General Conditions at Low-Slope Roof Areas

Debris needs to be removed from the roof areas. We believe the life of the membrane can be extended with careful cleaning, proper prep, priming, and polyurethane coating application.

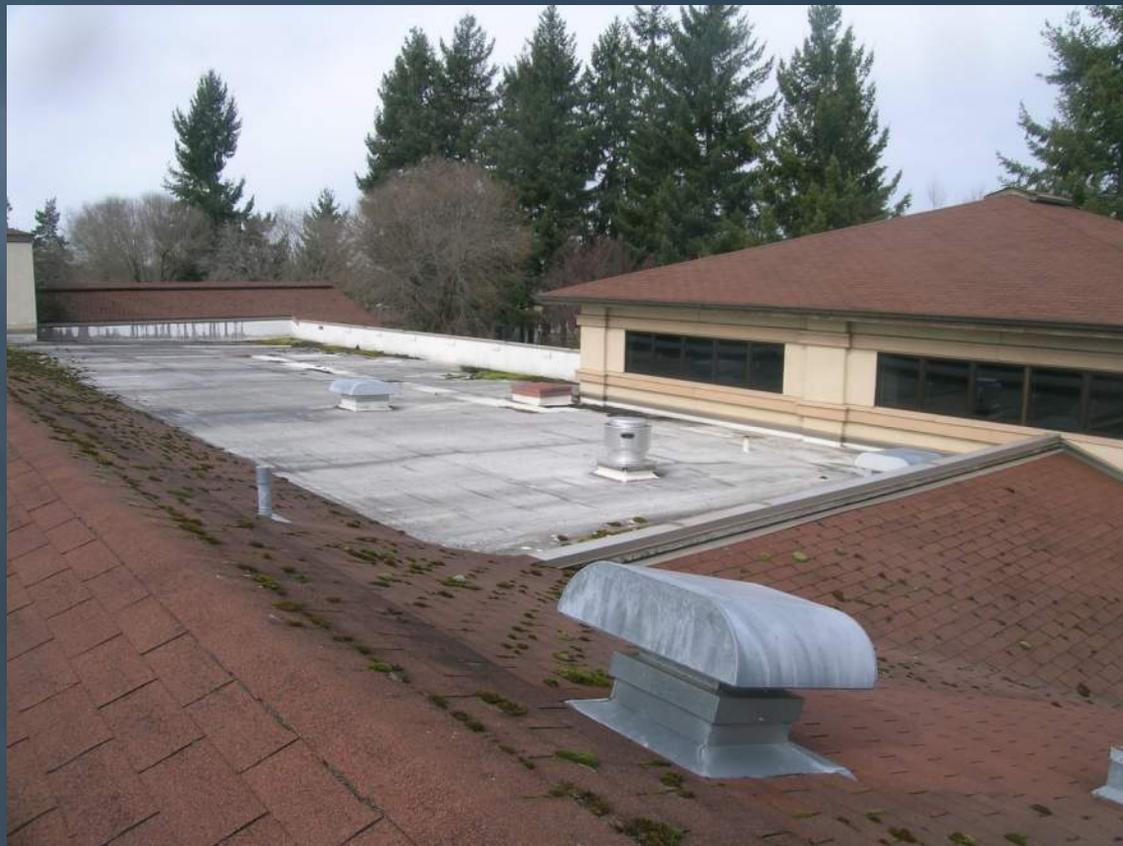
HEMLOCK-SPRUCE- LOW-SLOPE ROOF OBSERVATIONS

General Conditions at Low-Slope Roof Areas
Debris needs to be removed from the roof areas. We believe the life of the membrane can be extended with careful cleaning, prep, and coating application.
