Video Security Study Green Hill School

Security Design Agreement 2015-812B

Prepared By
KMB architects

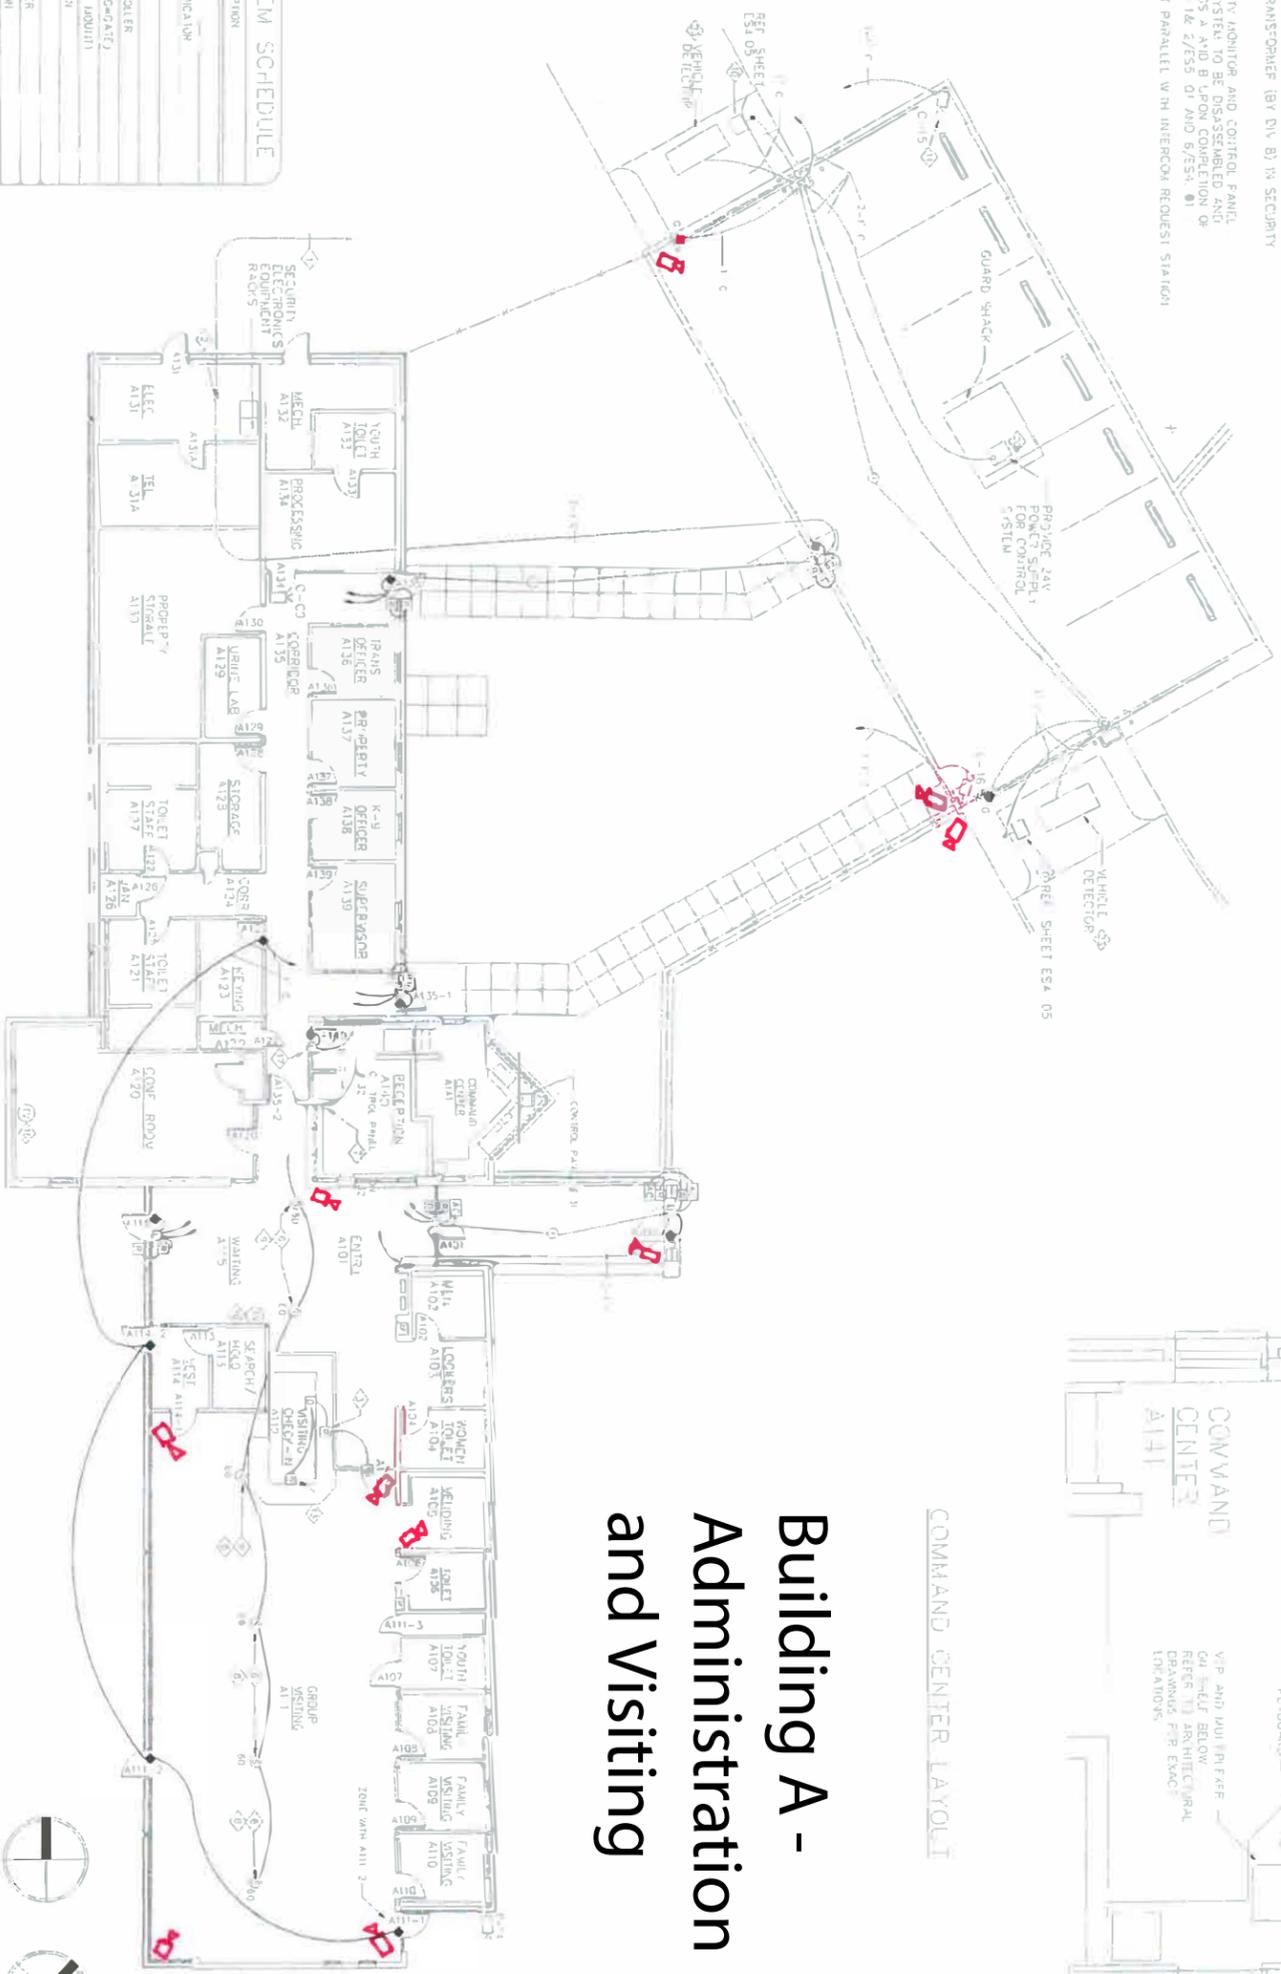
SECURITY FLOOR PLAN - BUILDING "A" AS-BUILT

Building A houses the control center and actively monitors the perimeter, sallyport and facility entrance cameras. The cameras are end of lie analog cameras on standalone DVR.

Option 2 - Replace existng analog cameras at sallyport and entrance and add IP cameras to visiting. Add network video recorder and matrix controller for monitoring perimeter and entrance cameras. Add video system control server for centralized management.

Building A - Administration and Visiting

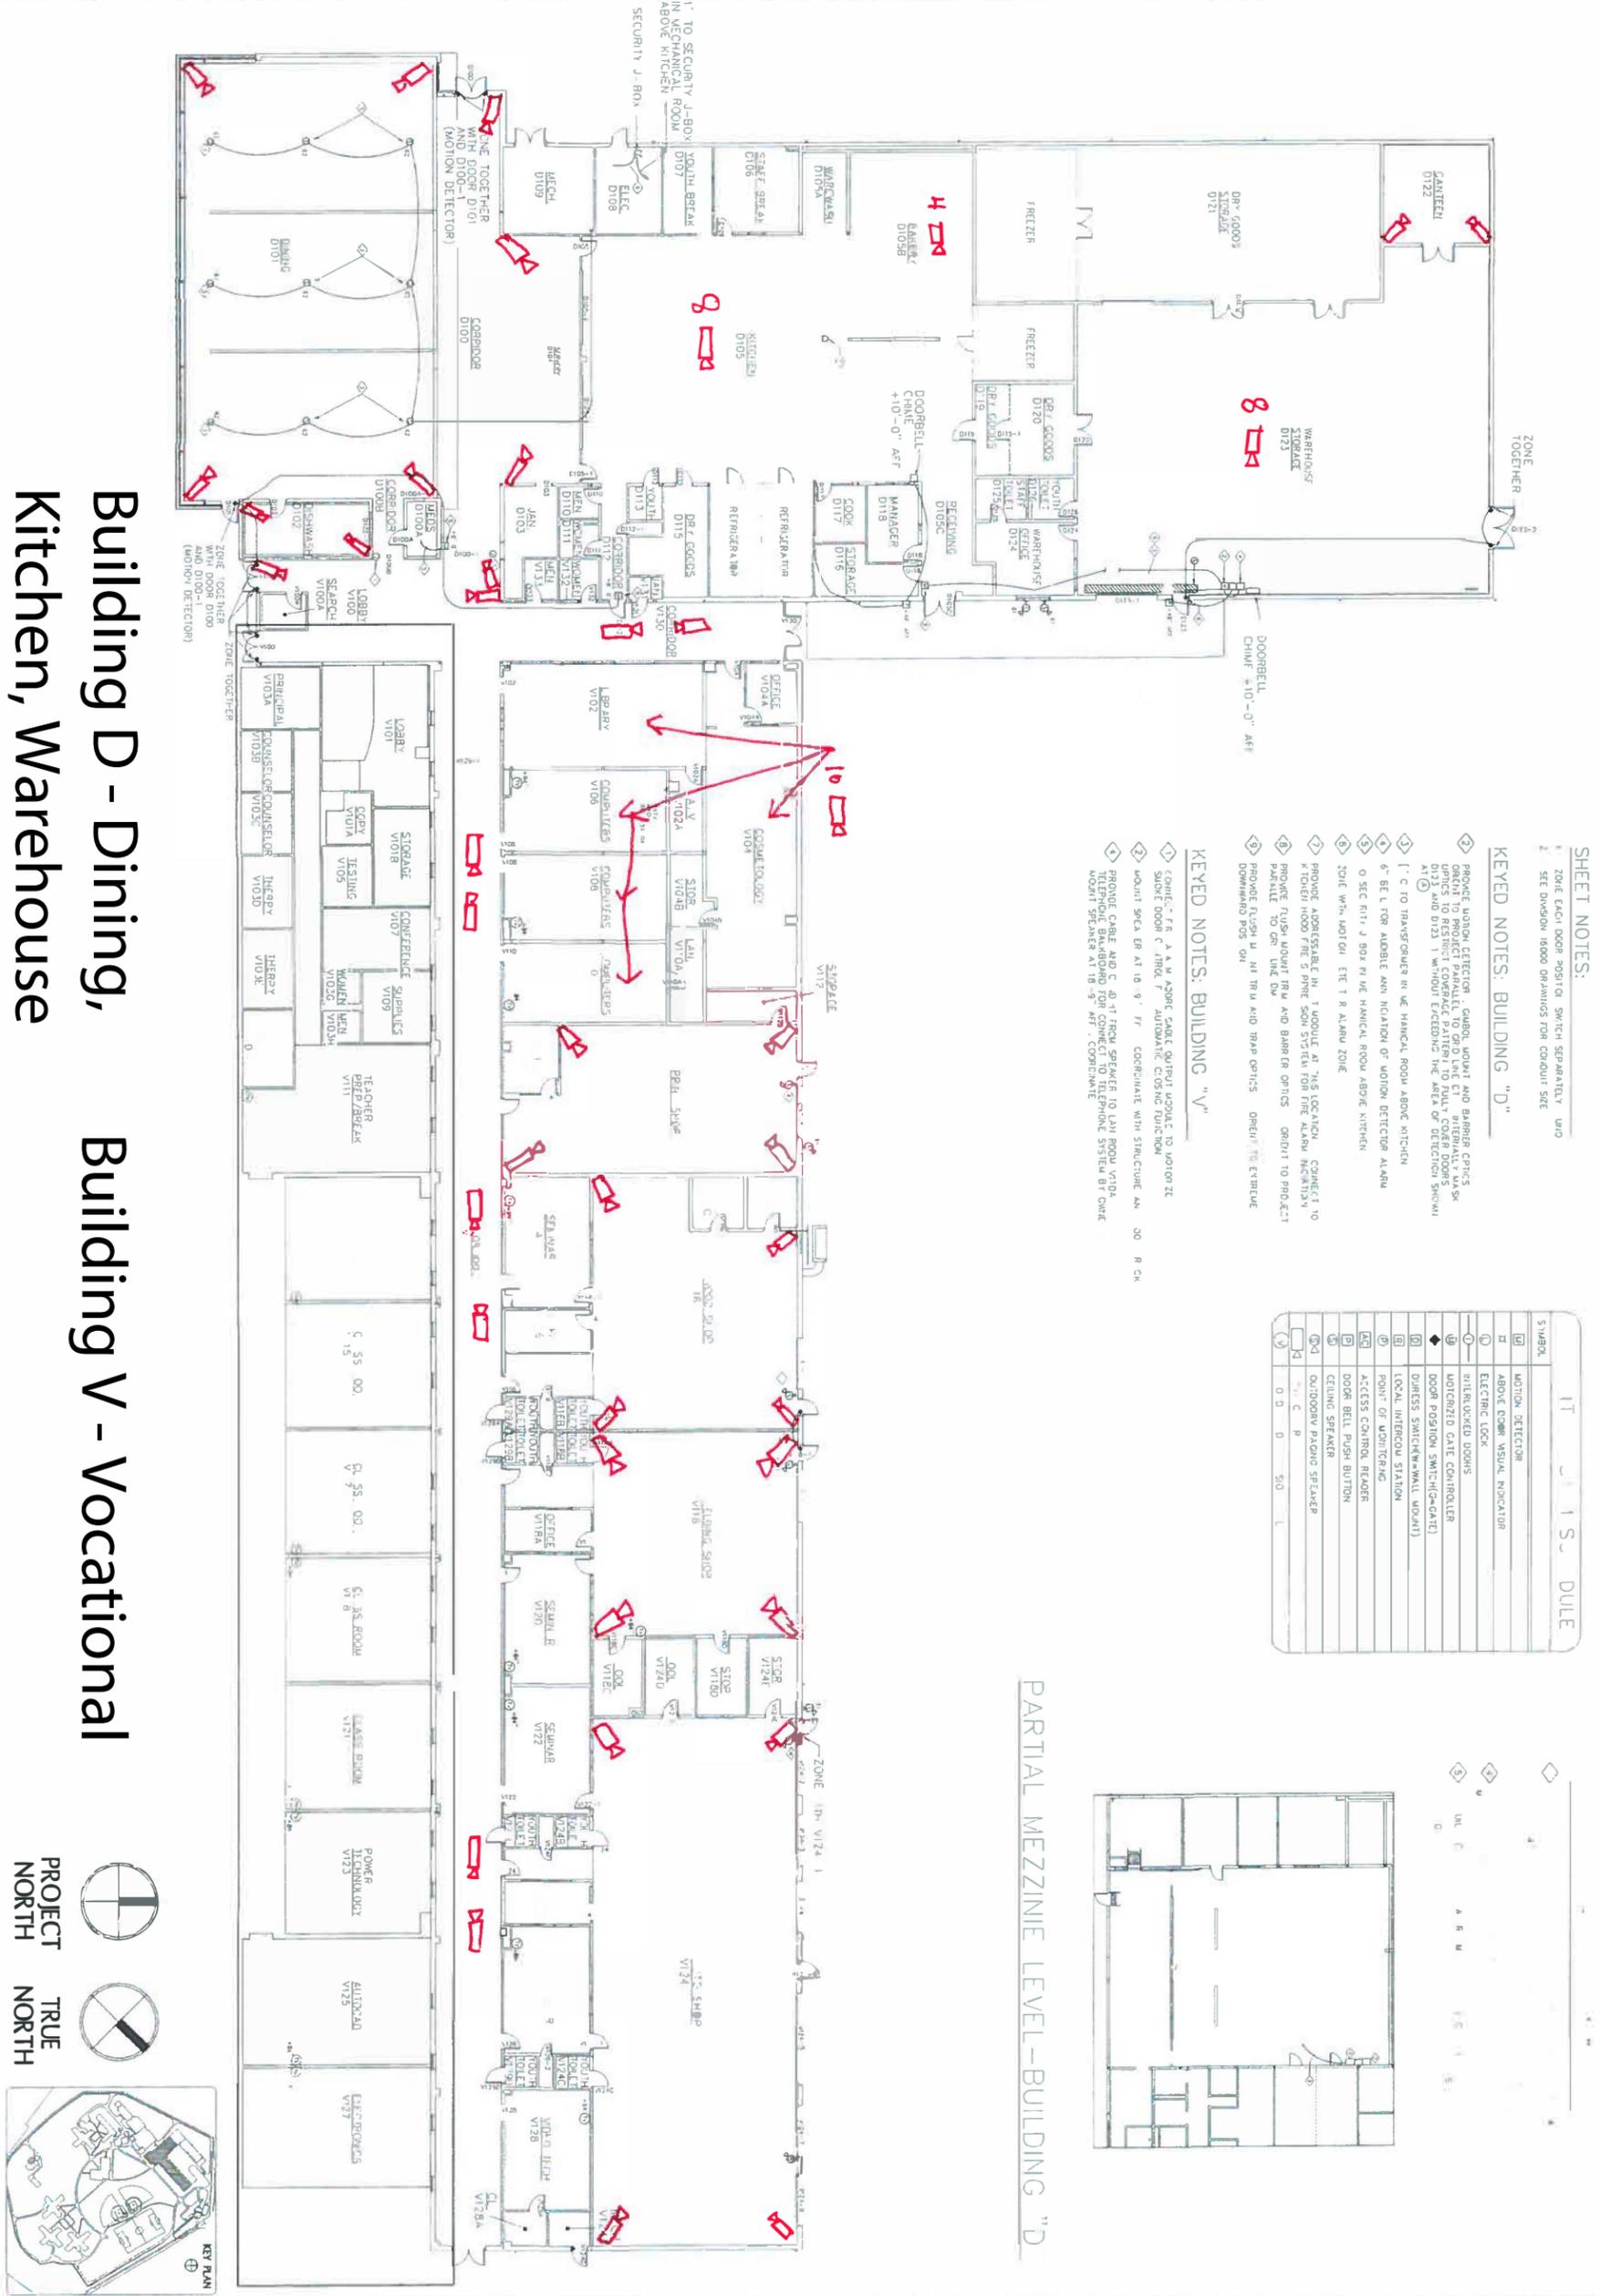
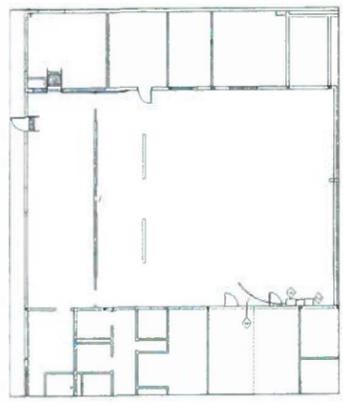
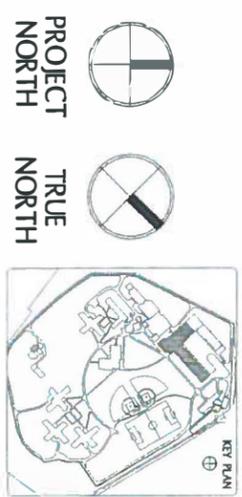
Option 2 - Add video cameras and NVR. Cut windows in to dishwashing area to provide direct supervision. Replace drop ceiling in dishwashing area and sewing room with security ceiling tile system.

PARTIAL MEZZINE LEVEL-BUILDING "D"

Building D - Dining, Kitchen, Warehouse

Building V - Vocational

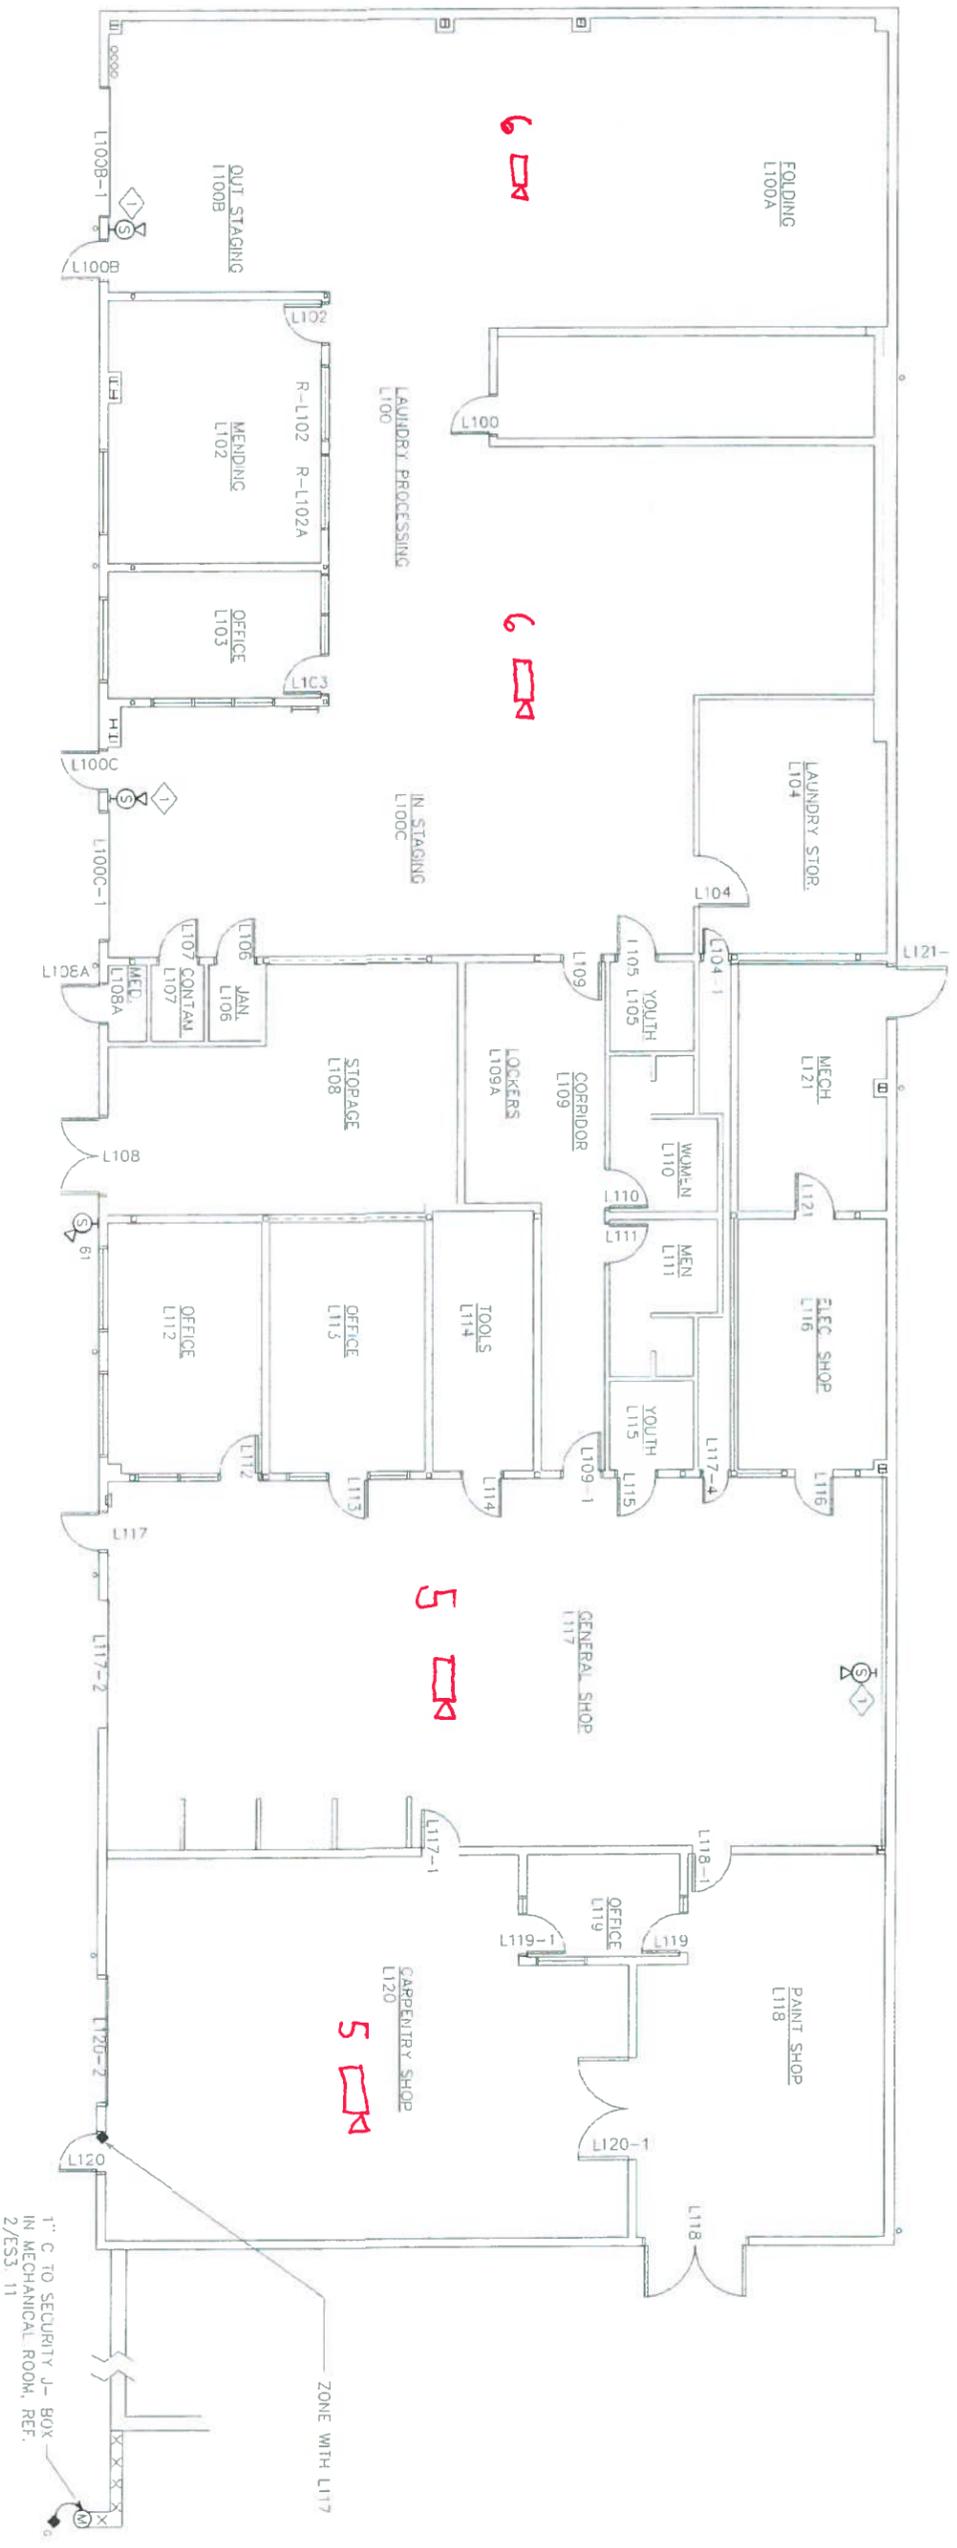
Building L - Laundry/Maintenance

Option 2 - Add video camera coverage

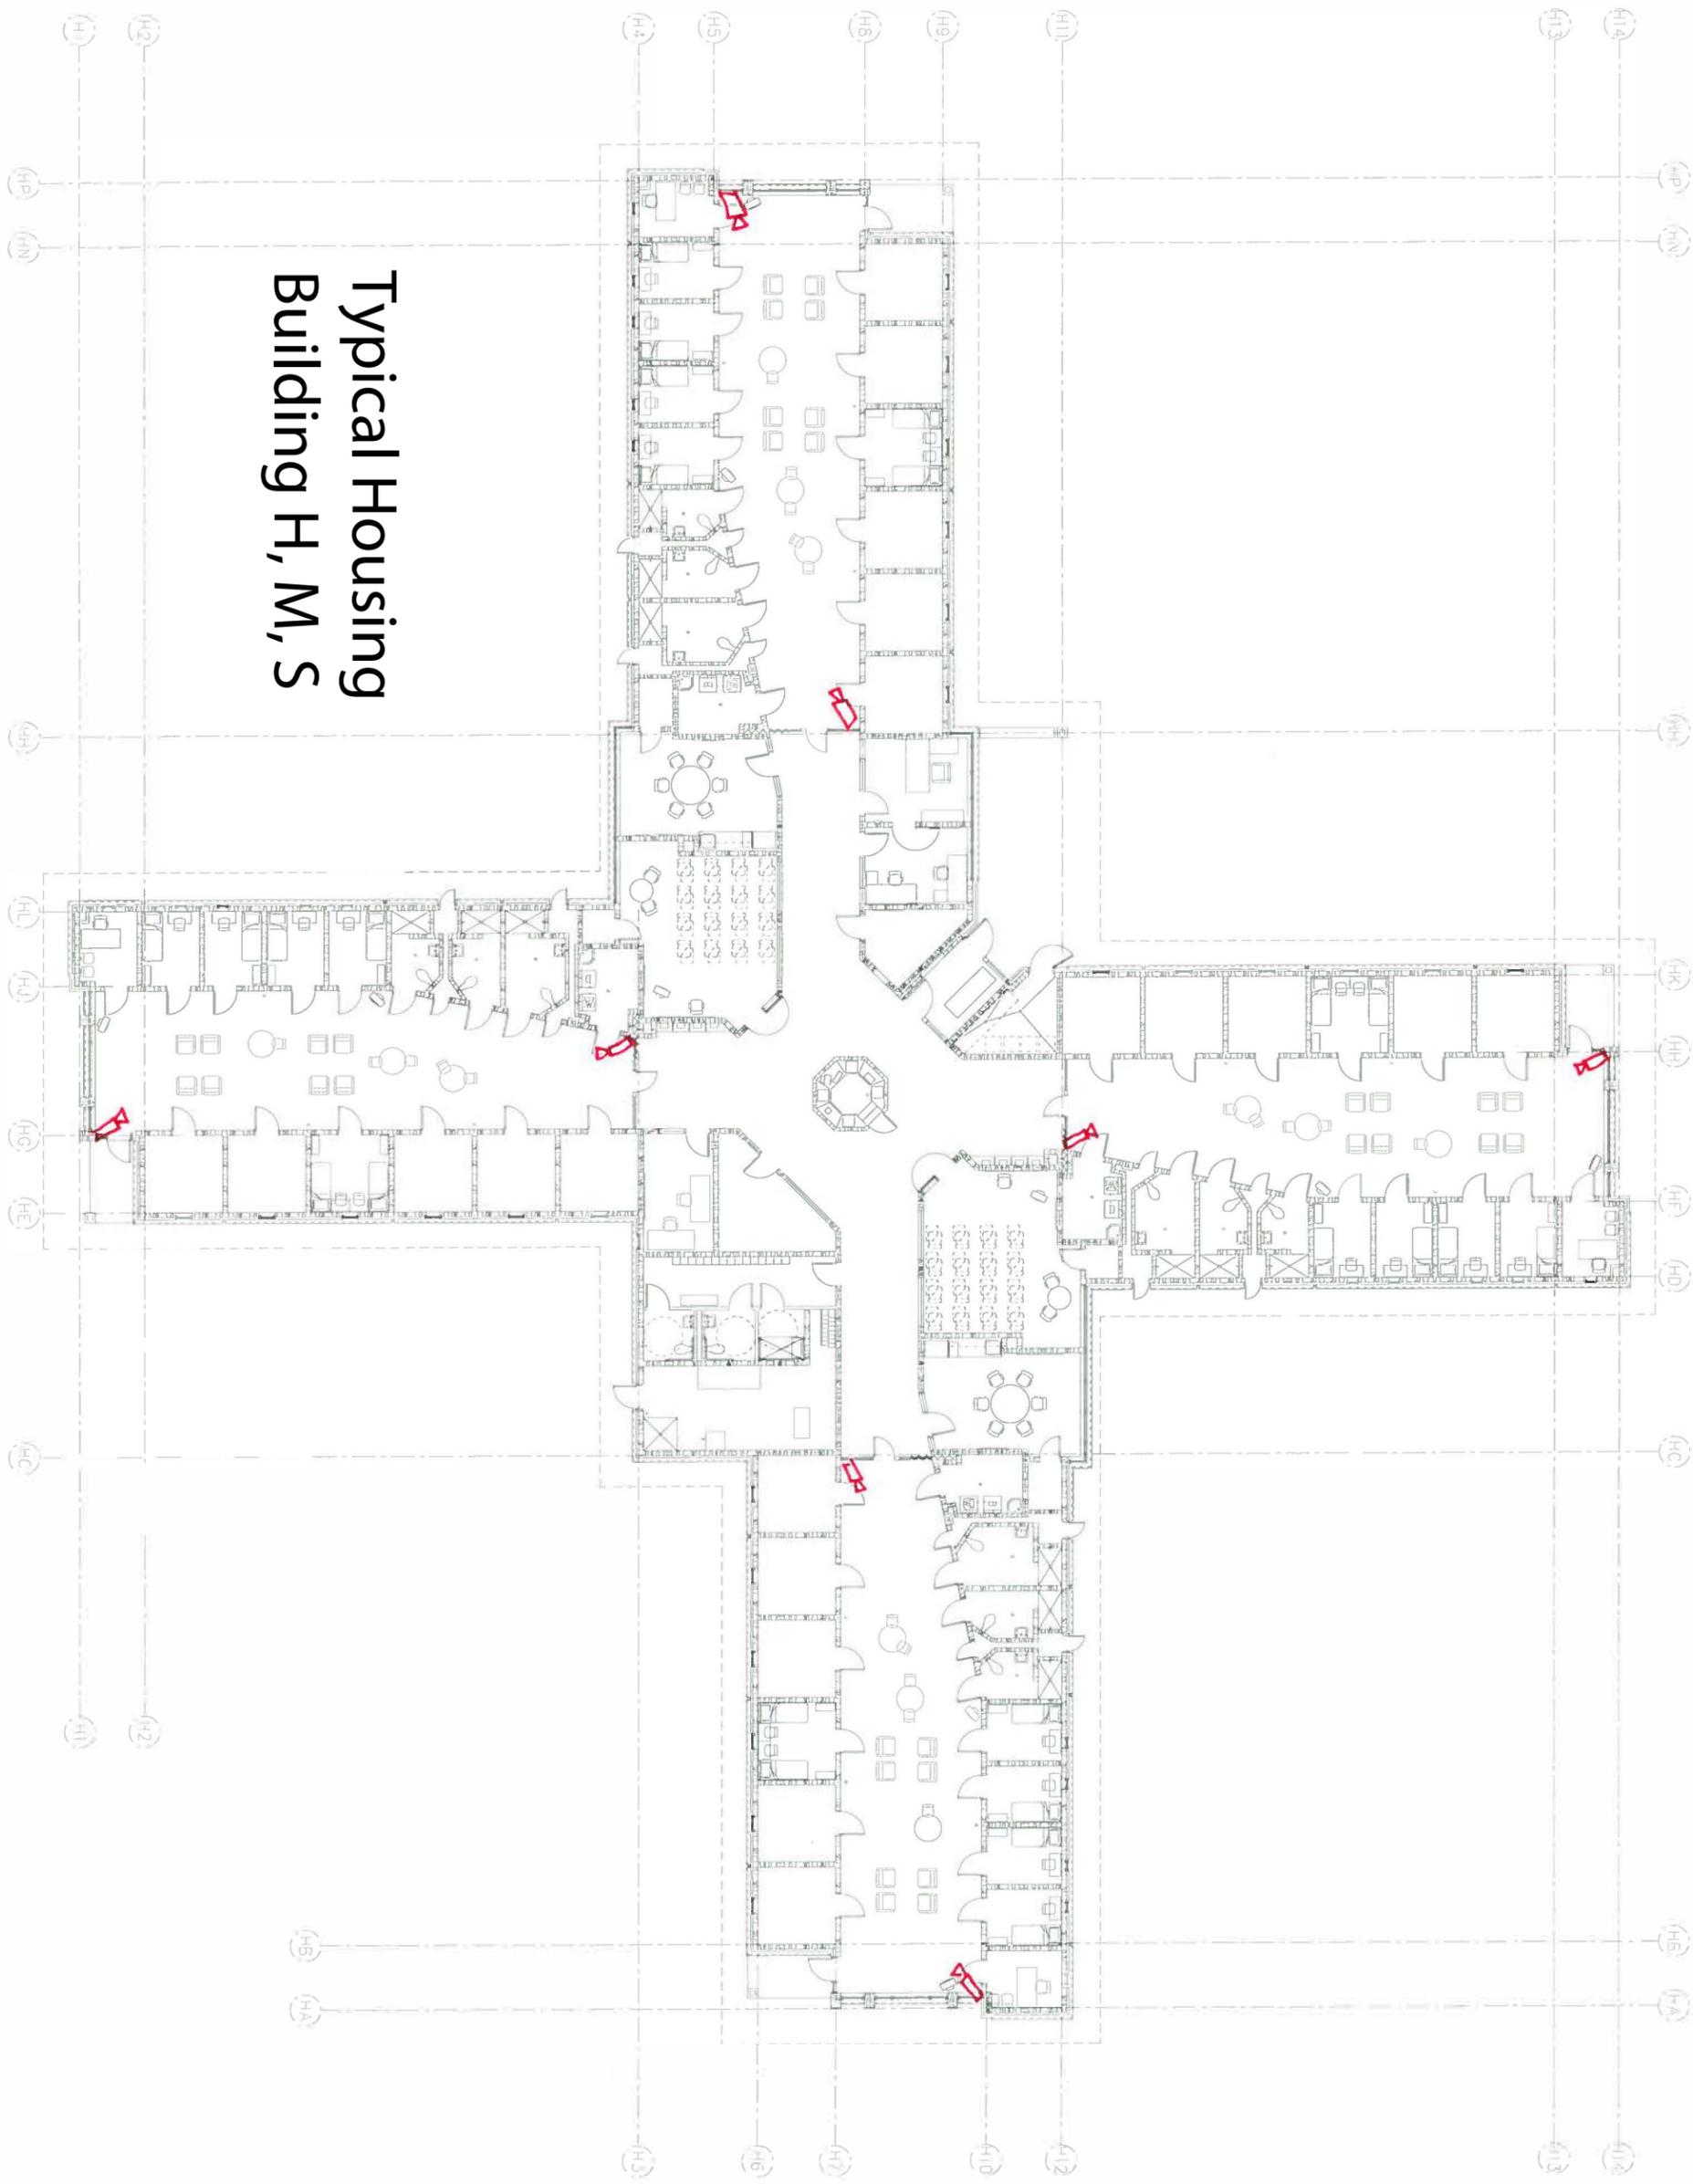
Typical Housing Building H, M, S

Option 2 - Add video camera coverage

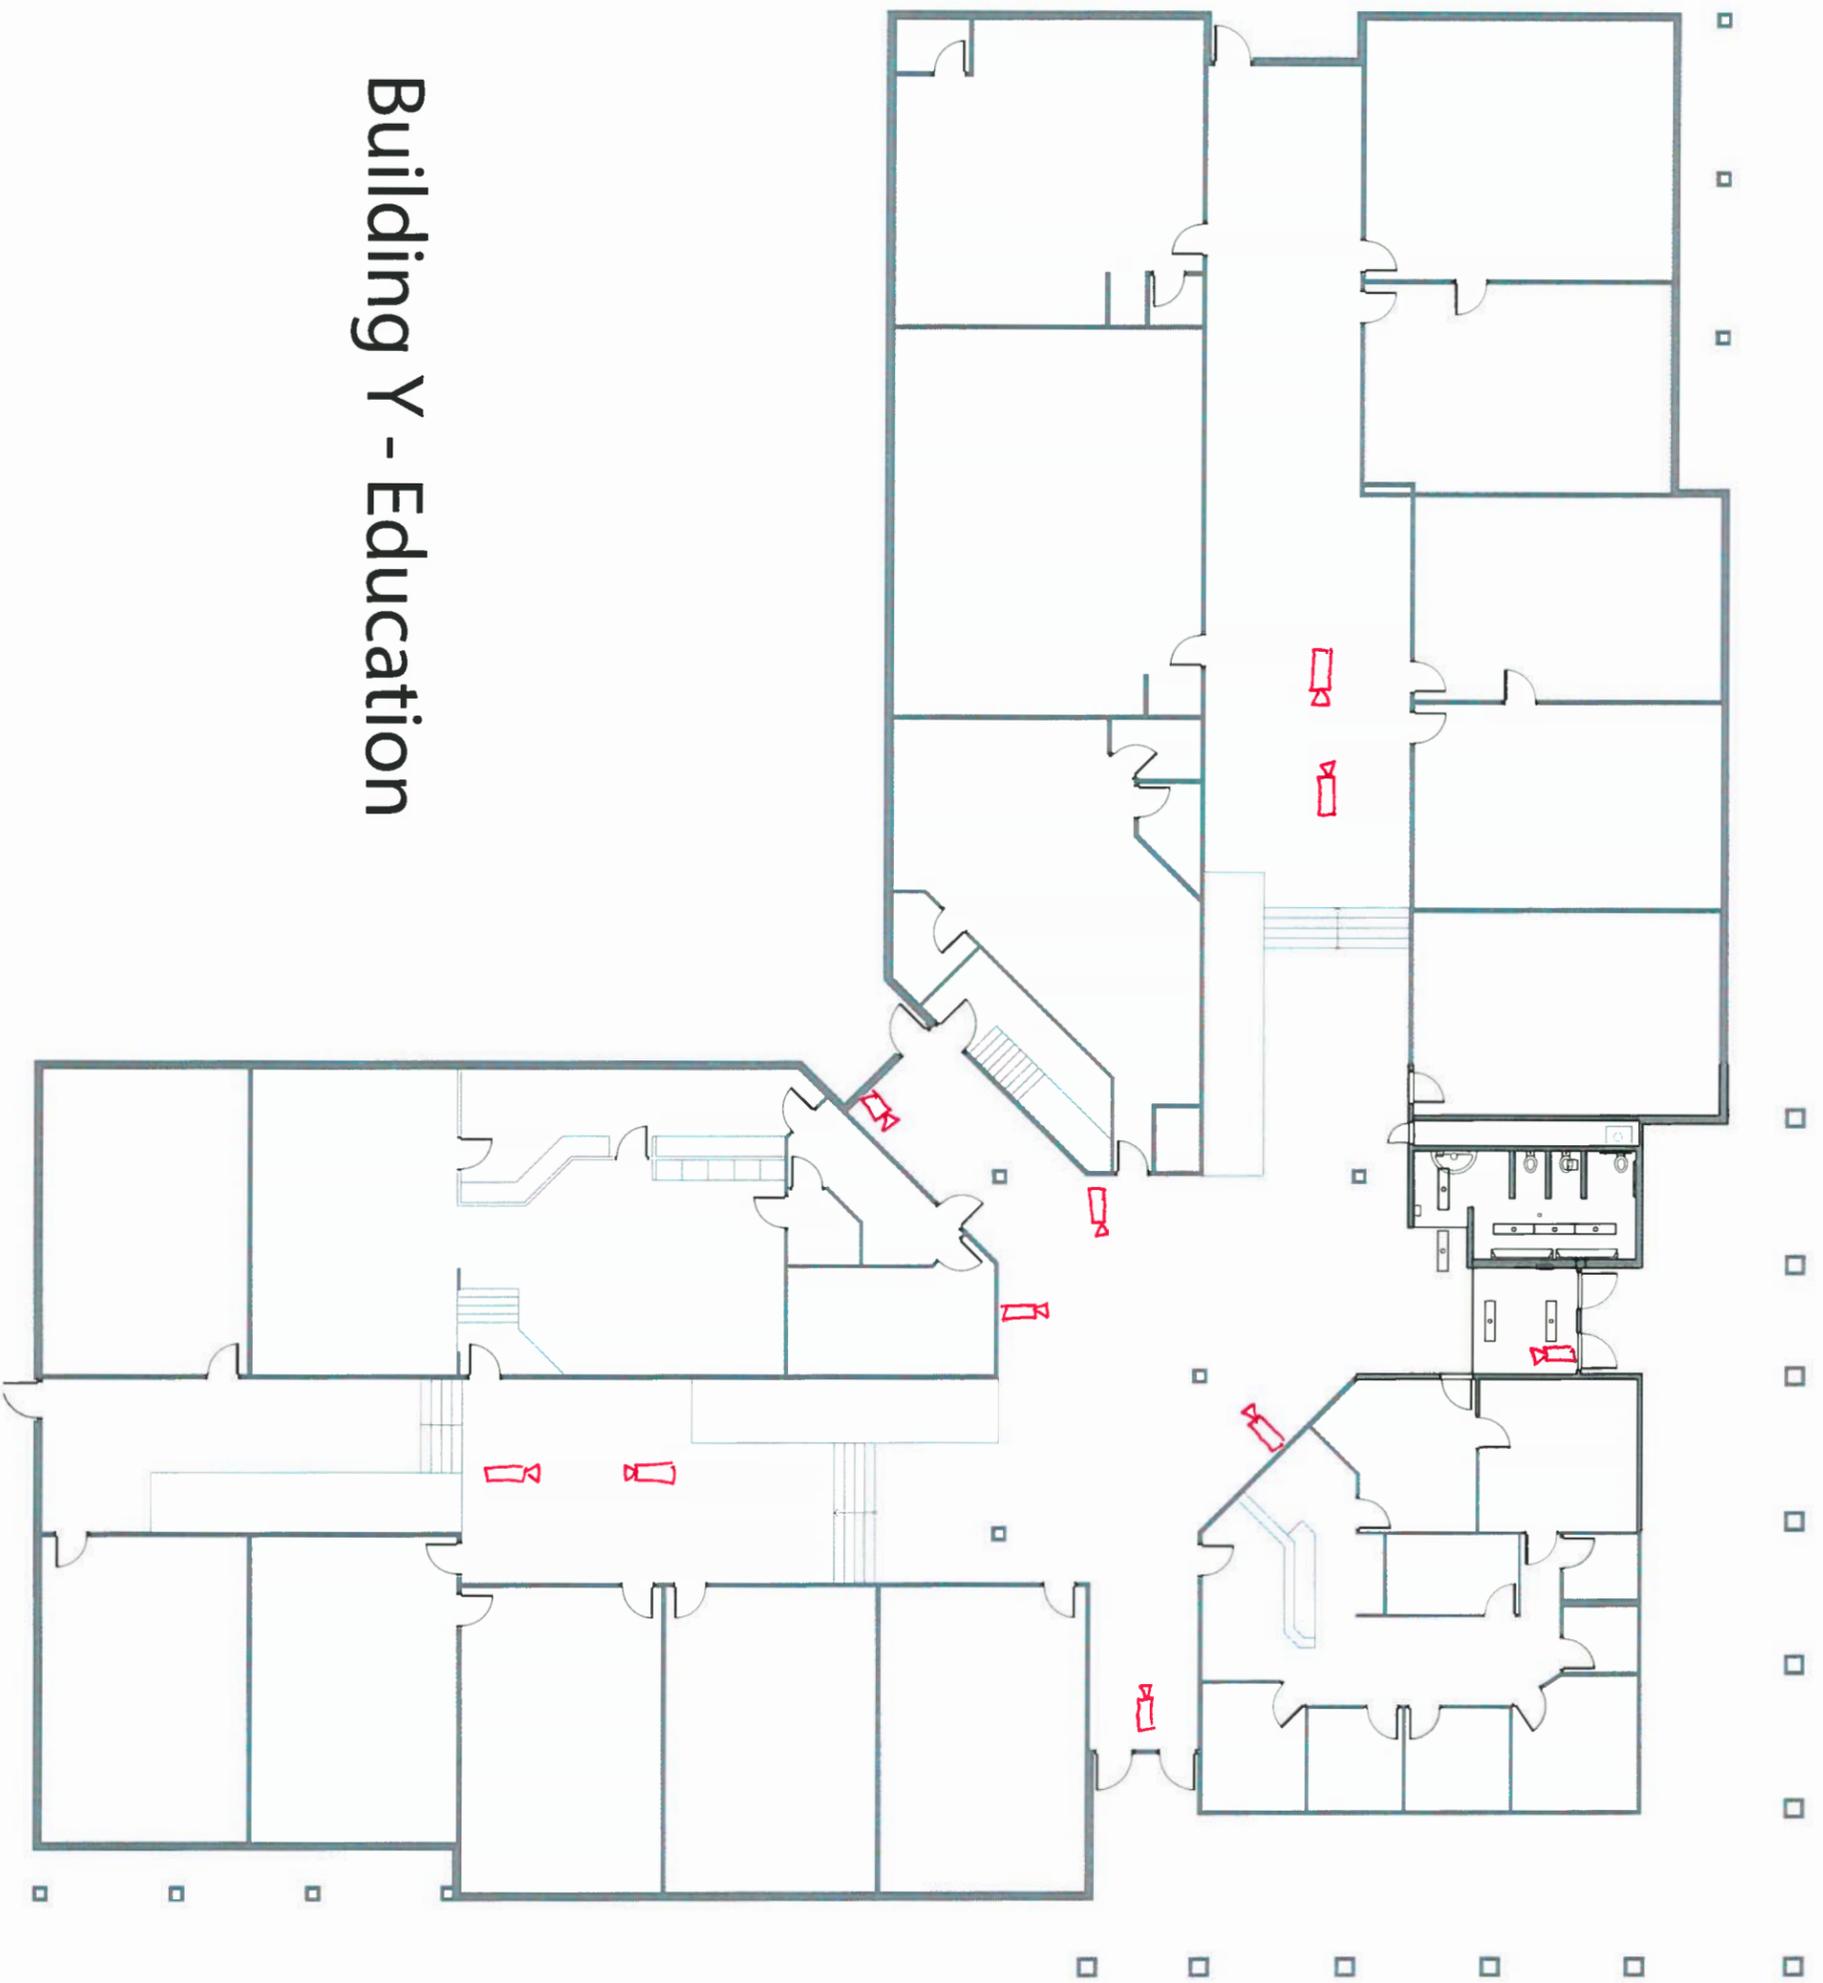
Building Y - Education

Option 2 - Add video camera coverage
