SURVEY FINDINGS & RECOMMENDATIONS

RAINIER SCHOOL – BUCKLEY, WA

**OAKLEY HALL AND MEYER HALL ROOFING REPAIRS
AND HEMLOCK-SPRUCE HALL PARTIAL
REROOFING AND REPAIR PROJECT**

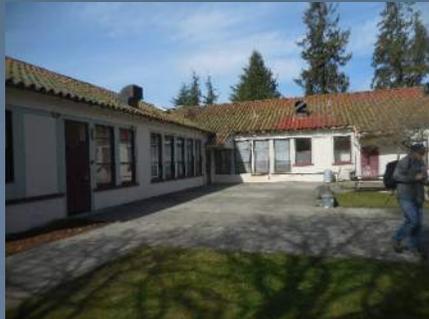
OAKLEY HALL-- OVERVIEW

Overview of Conditions at Oakley Hall

Reports of water intrusion primarily appear to be related to aged valley flashing conditions and defective flashings at select HVAC related penetrations.

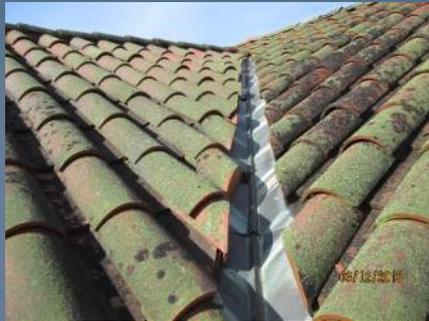
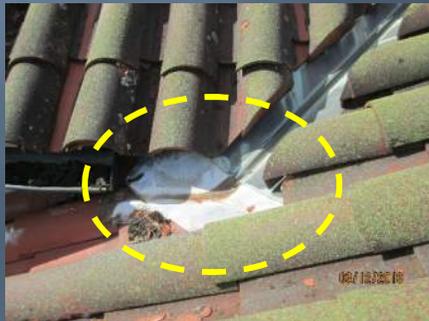
OAKLEY HALL— VALLEY FLASHINGS

Photos of conditions at typical valley

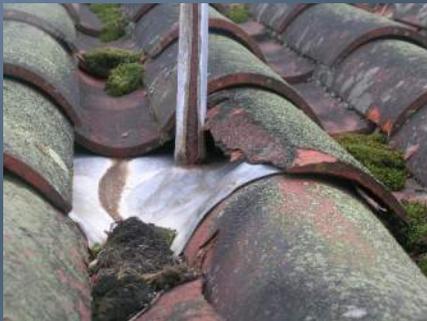
OAKLEY HALL— PIPE PENETRATION FLASHINGS

Photos of conditions at pipe penetration near northwest corner of building

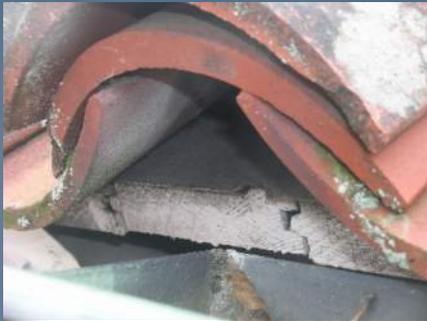
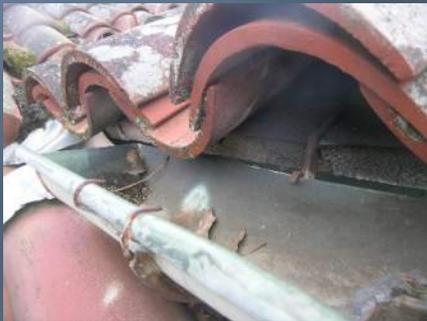
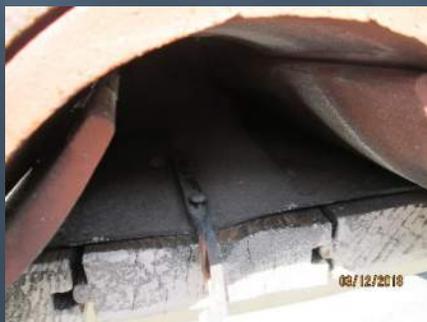
OAKLEY HALL— DOWNSLOPE EAVE EDGE CONDITIONS

Photos of conditions at downslope eave edge flashings.

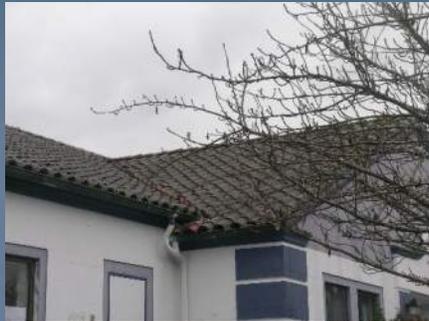
MEYER HALL-- OVERVIEW

Overview of Conditions at Meyer Hall

Reports of water intrusion also appear to be primarily related to valley flashing conditions and flashings at select HVAC units' penetrations.

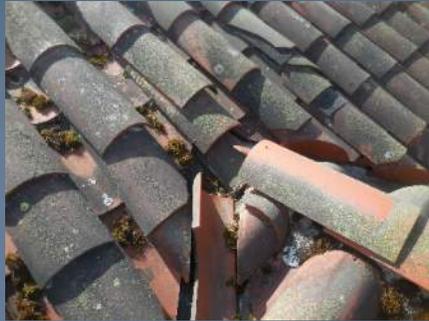
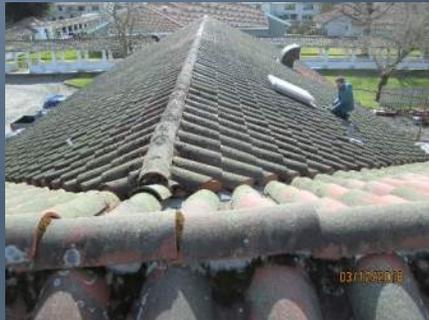
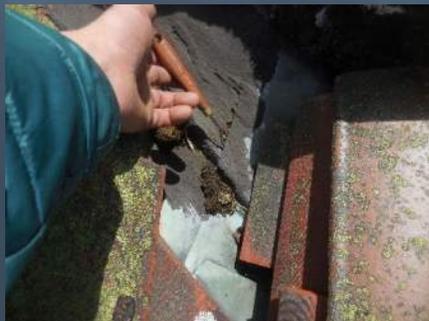
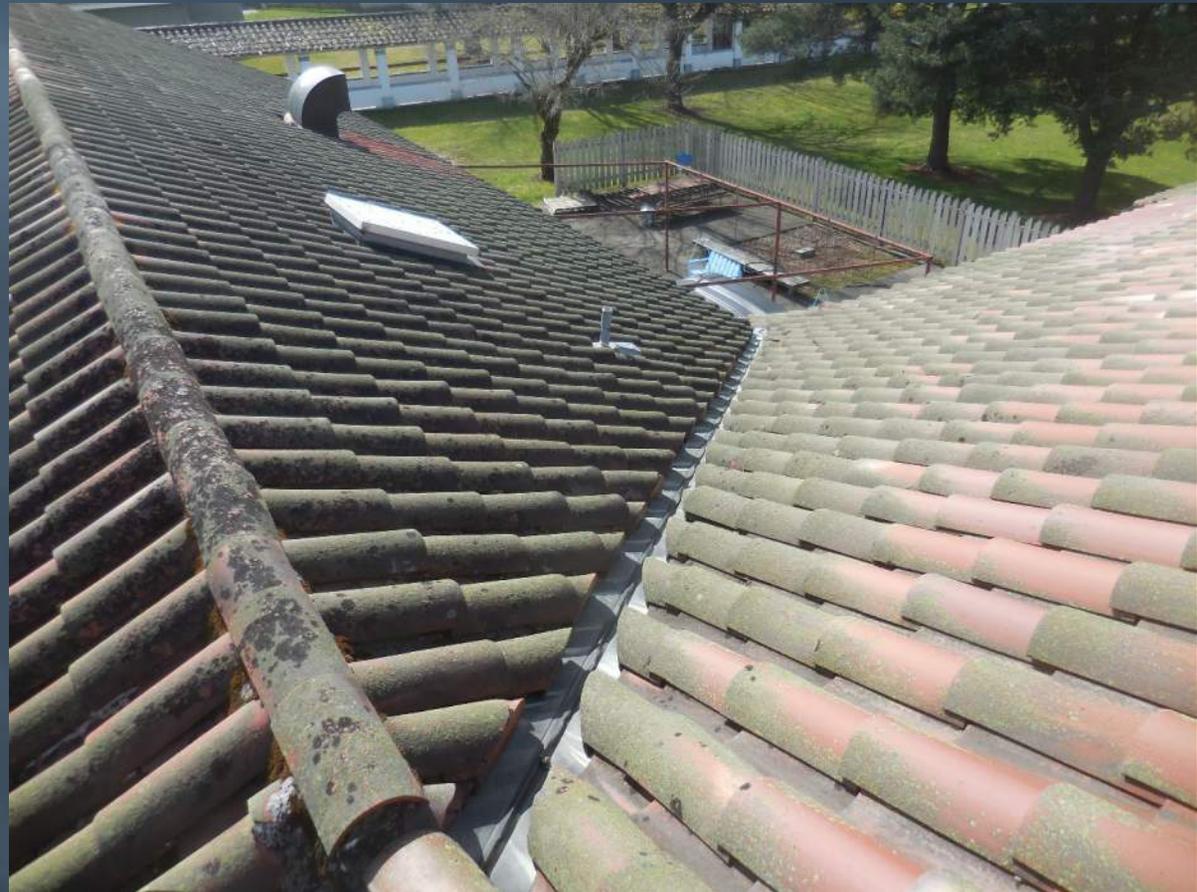
MEYER HALL— ROOFING OVERVIEW

Overview of Roof Level Conditions

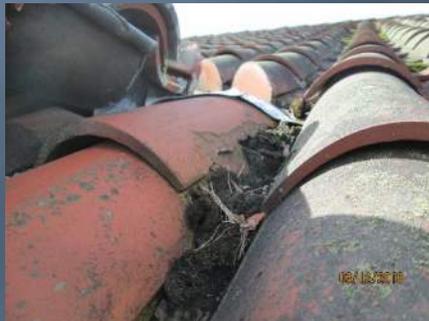
MEYER HALL— VALLEY CONDITIONS

Overview of Roof Level Valley Conditions

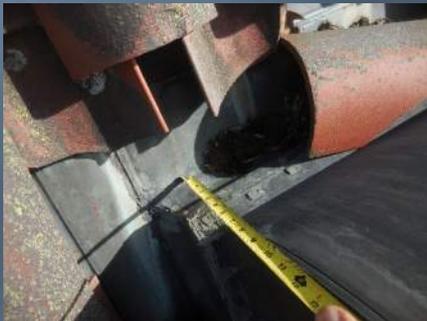
MEYER HALL— VENT HOOD FLASHINGS

Photos of flashing conditions at typical HVAC Hood.

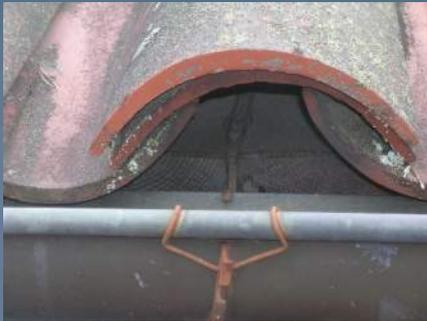
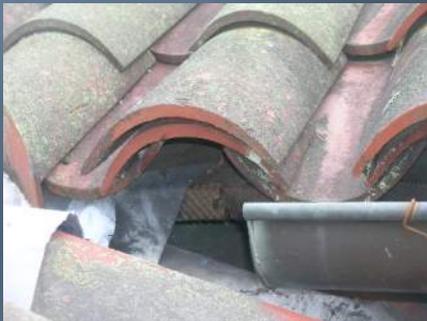
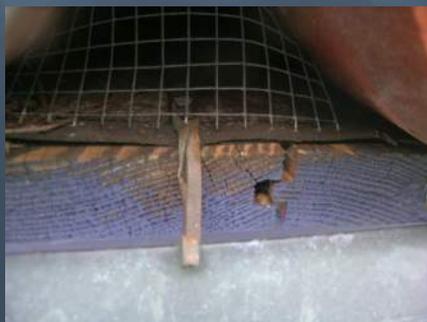
MEYER HALL— DOWNSLOPE EAVE EDGE CONDITIONS

Photos of conditions at downslope eave edge flashings.

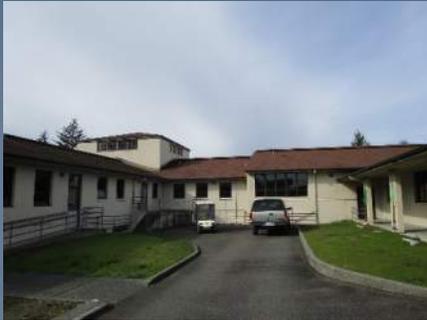
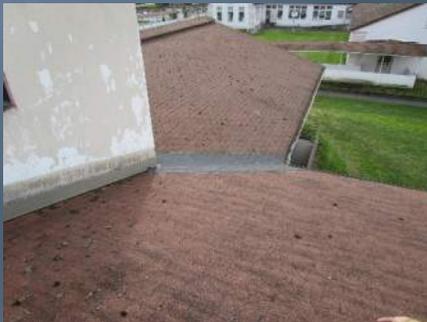
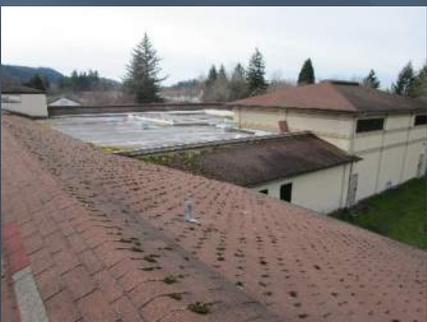
HEMLOCK-SPRUCE- OVERVIEW OF ROOF CONDITIONS

Overview of Conditions at hemlock-Spruce Hall
The existing 3-tab asphalt shingles appear to be approaching 26+ years of service life, are cracking and are generally in need of replacement.

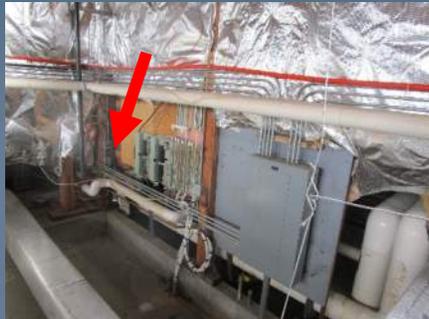
HEMLOCK-SPRUCE- CONDITIONS AT CUPOLAS

General Conditions at Cupolas

Water intrusion appears to be occurring at roof-to-wall transition at areas related to valley flashings.

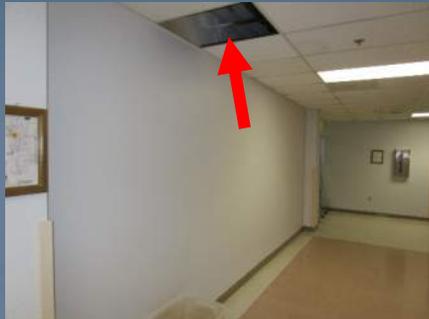
HEMLOCK-SPRUCE- REPORTED LEAK LOCATIONS

Water Intrusion Beneath Woven Valleys

Water intrusion reported in hallway near wood shop appears to be emanating from asphalt shingle woven valley.

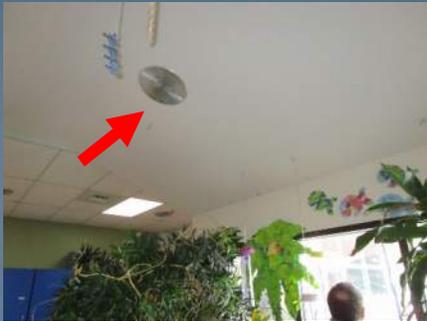
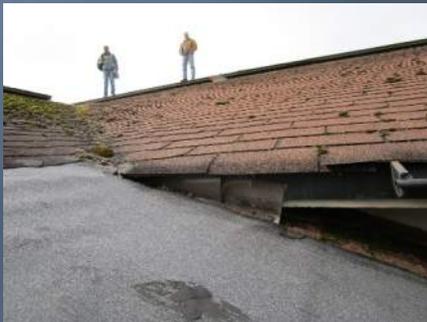
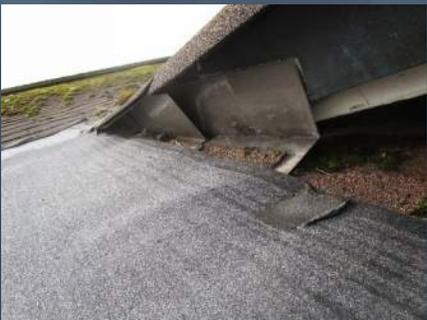
HEMLOCK-SPRUCE- REPORTED LEAK LOCATIONS

Water Intrusion at Valley-to-Roof Transition at Art Room
Water intrusion reported in the Arts Classroom appears to be related to valley-to-intersecting roof transition.

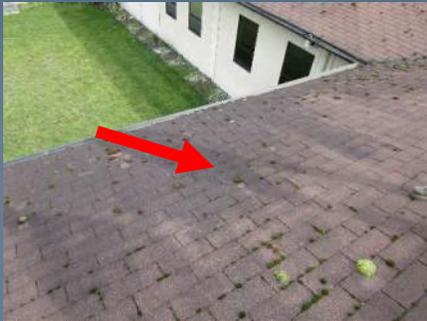
HEMLOCK-SPRUCE- REPORTED DECAYED SHEATHING

Soft, Decayed Sheathing Beneath Shingles

Although no interior leaks have been reported at this area, the sheathing is decayed / degraded and quite soft. Replacement of sheathing is needed.

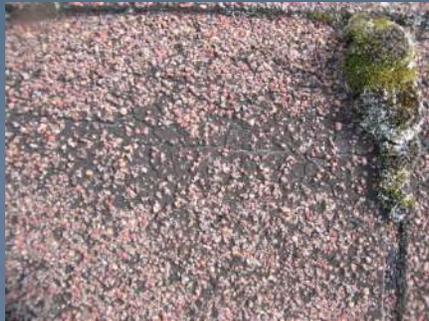
HEMLOCK-SPRUCE- SHINGLE CONDITION

Overall Condition of Existing 3-tab Asphalt Shingles
The existing 3-tab asphalt shingles are generally in poor condition. Extensive granule loss is widespread with reinforcing degrading from long-term exposure.

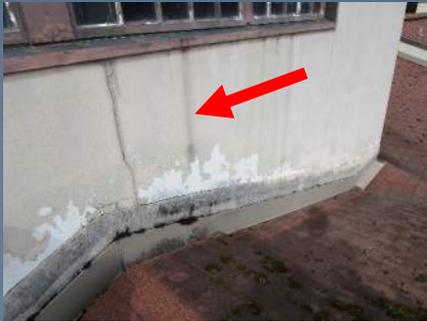
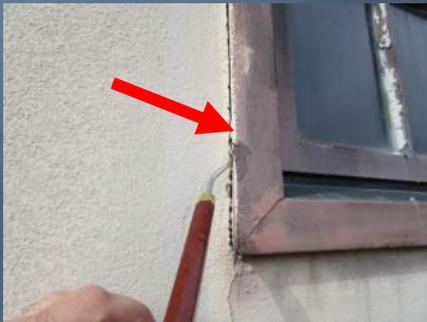
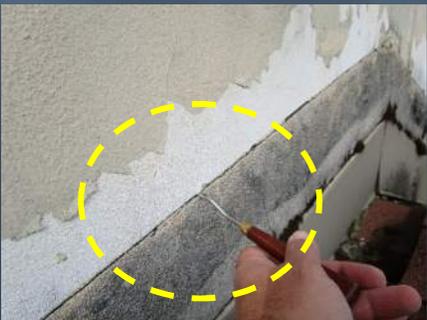
HEMLOCK-SPRUCE- CONDITIONS AT CUPOLA

General Conditions at Cupolas

Water intrusion appears to be occurring at roof-to-wall transition at areas related to valley flashings.

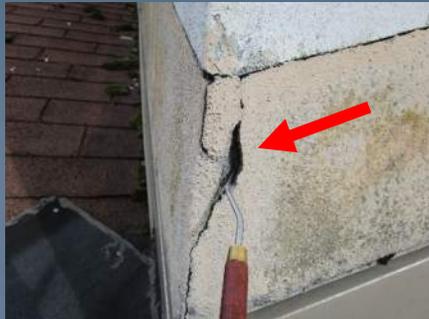
HEMLOCK-SPRUCE- CONDITIONS AT CUPOLA

General Conditions at Cupolas

Stucco repairs and proper integration with weather-resistive barrier are needed as part of the retrofit of roof-to-wall flashing details.

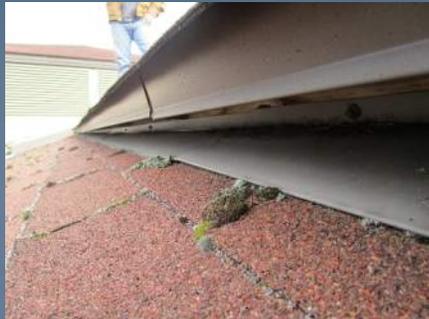
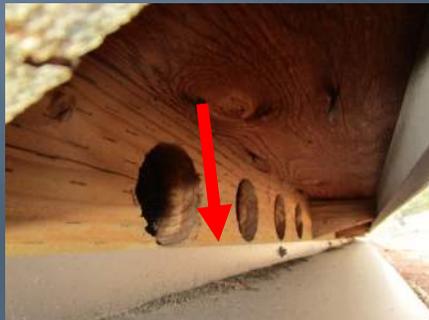
HEMLOCK-SPRUCE- RIDGE VENT OBSERVATIONS

General Conditions at Ridge Vents

Wood-framed ridge vents have experienced shingles being blown off and are susceptible to water intrusion and wind-driven rain.

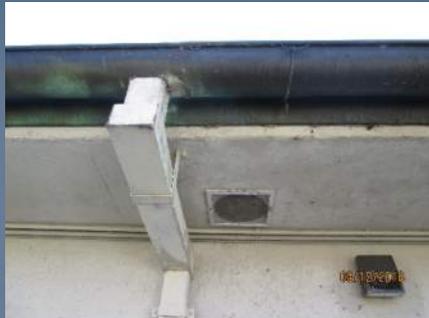
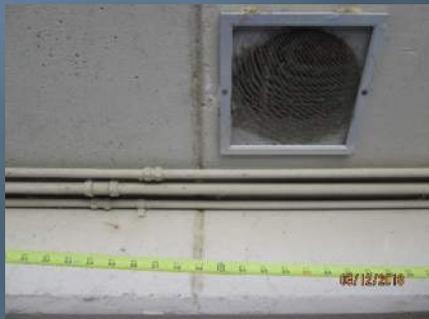
HEMLOCK-SPRUCE- SOFFIT VENT OBSERVATIONS

General Conditions at Soffit Vents

Downslope eave in-take air ventilation provided by intermittent 6" diameter soffit vents at some locations, and strip vents at others.

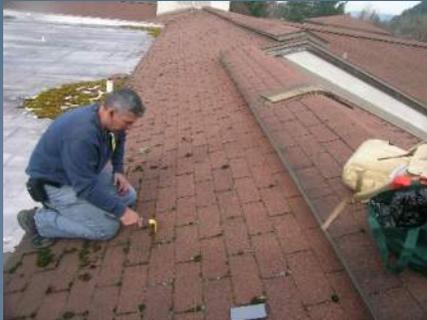
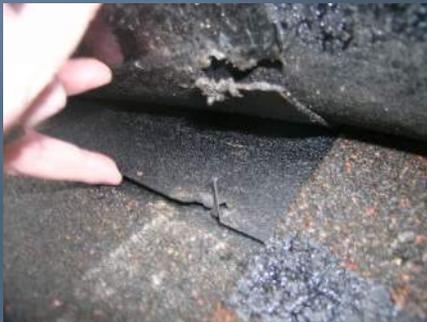
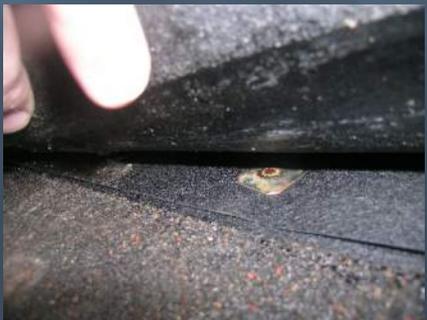
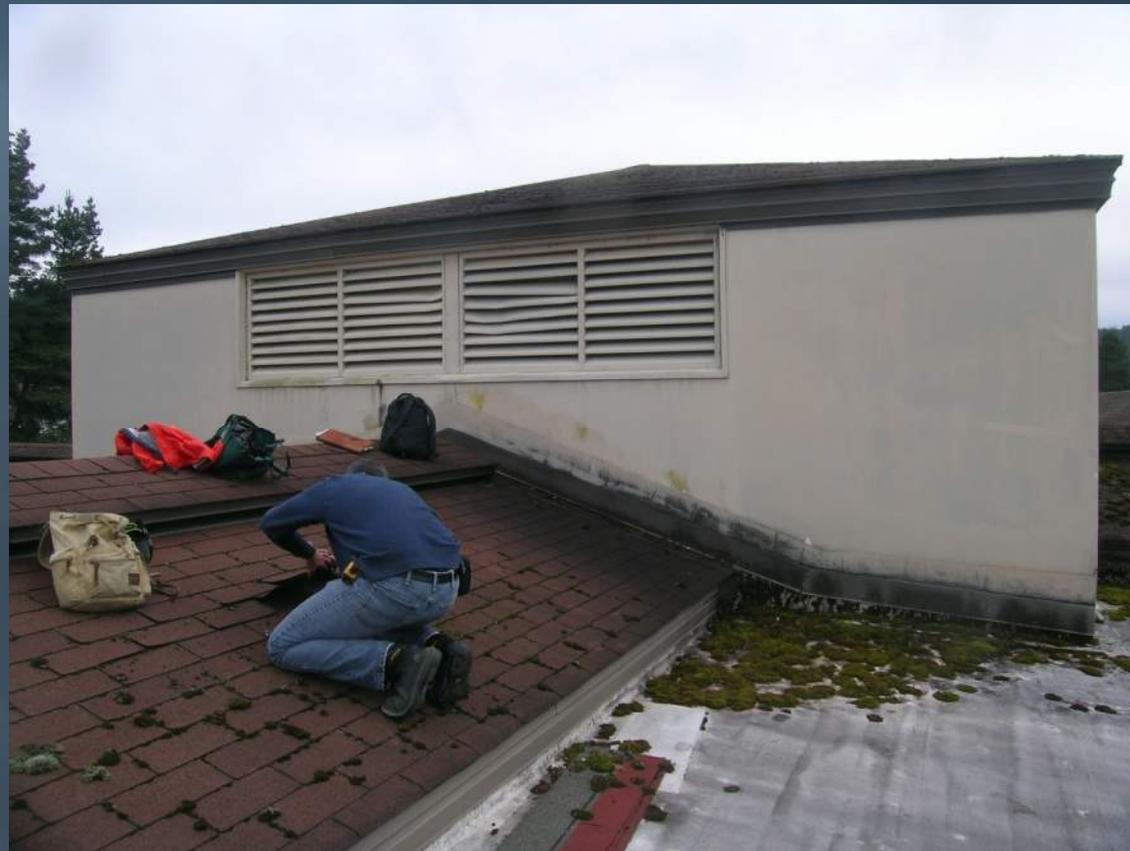
HEMLOCK-SPRUCE- SHINGLE TEST OPENING

Observations at Test Opening

Select shingles were carefully removed, which revealed just one layer of No. 15 asphalt-saturated underlayment over plywood sheathing.

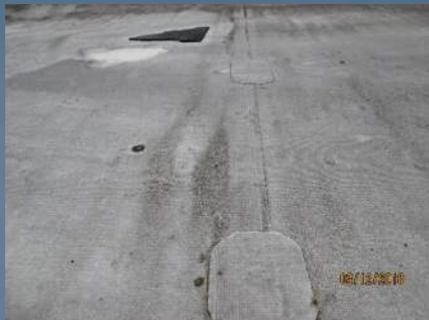
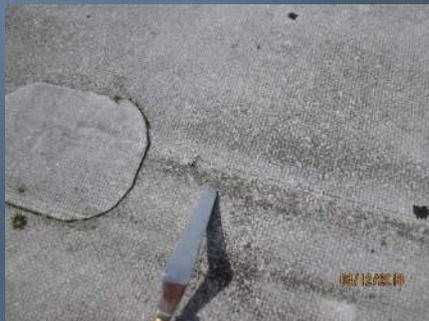
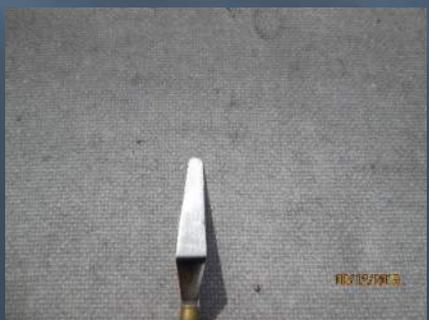
HEMLOCK-SPRUCE- LOW-SLOPE ROOF OBSERVATIONS

General Conditions at Low-Slope Roof Areas

Debris needs to be removed from the roof areas. We believe the life of the membrane can be extended with careful cleaning, proper prep, priming, and polyurethane coating application.

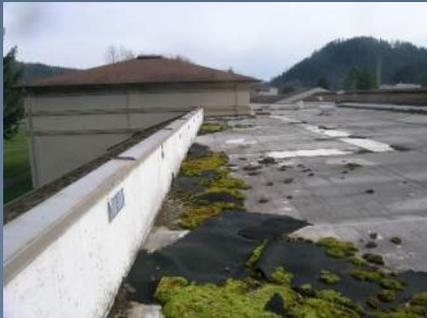
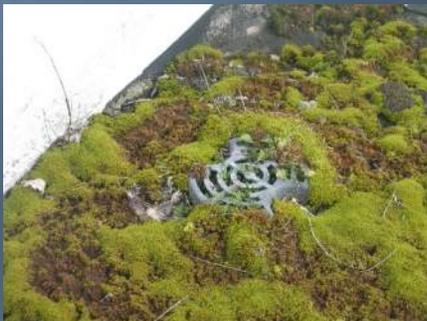
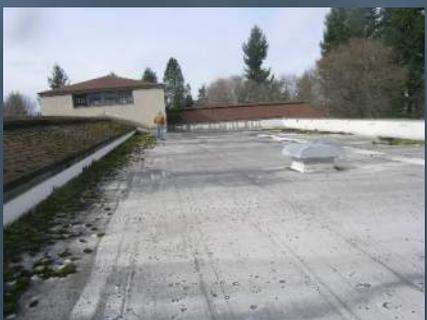
HEMLOCK-SPRUCE- LOW-SLOPE ROOF OBSERVATIONS

General Conditions at Low-Slope Roof Areas
Debris needs to be removed from the roof areas. We believe the life of the membrane can be extended with careful cleaning, prep, and coating application.
